Monitoring of the Noosa River Oyster Reefs; November 2017 - November 2018

Report to Noosa Council, and Queensland Department of Agriculture and Fisheries

December 2018

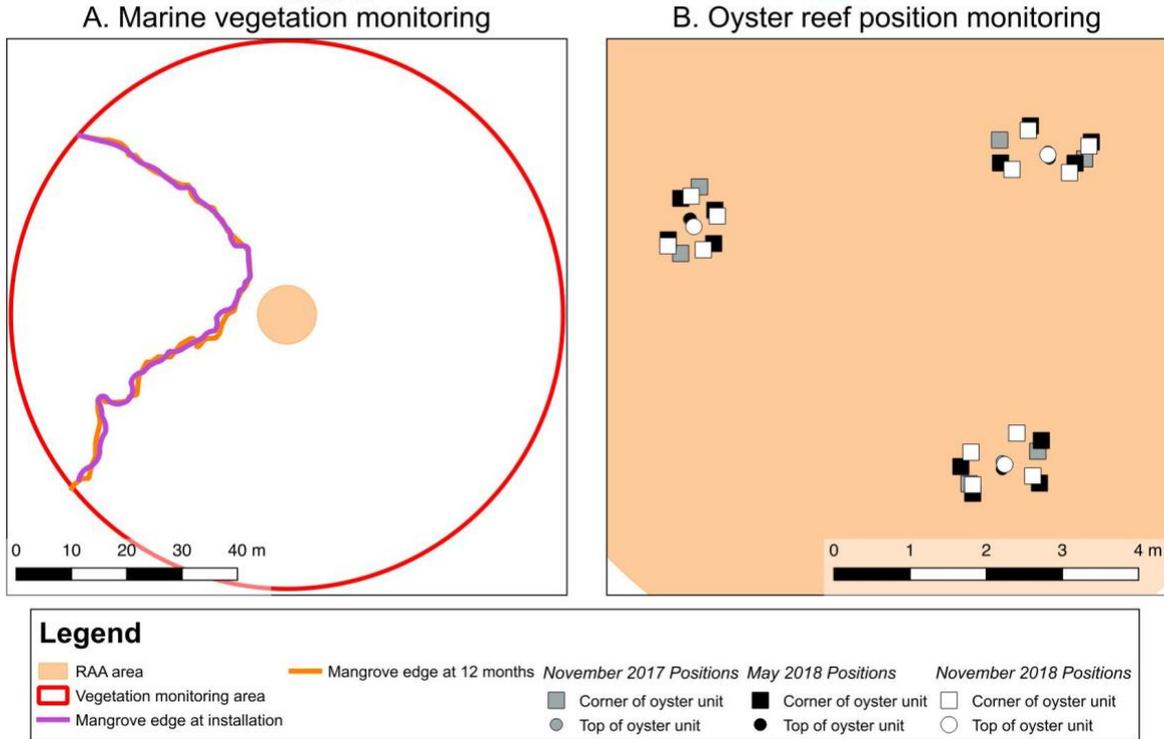
Site 2

Figure 5 Map of (A) mangrove edges and (B) oyster reef unit positions (at installation, and at 6 and 12 months post installation) at site 2 in the Noosa River.

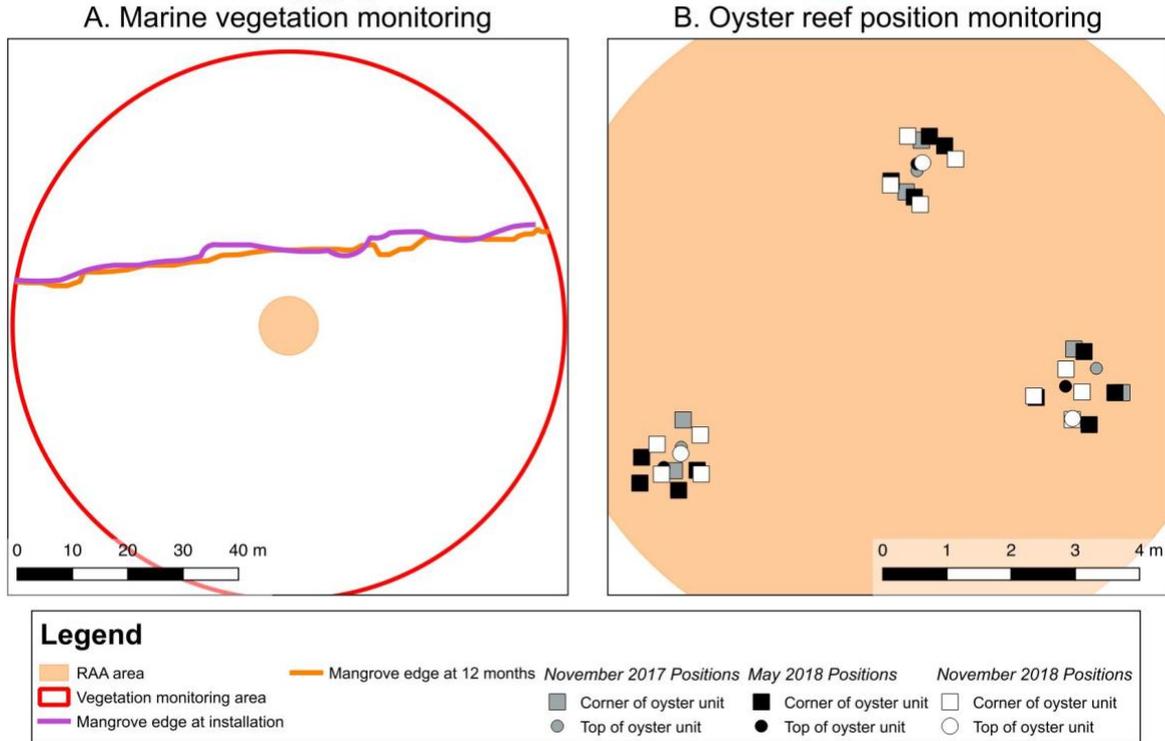
Site 8

Figure 11 Map of (A) mangrove edges and (B) oyster reef unit positions (at installation, and at 6 and 12 months post installation) at site 8 in the Noosa River.

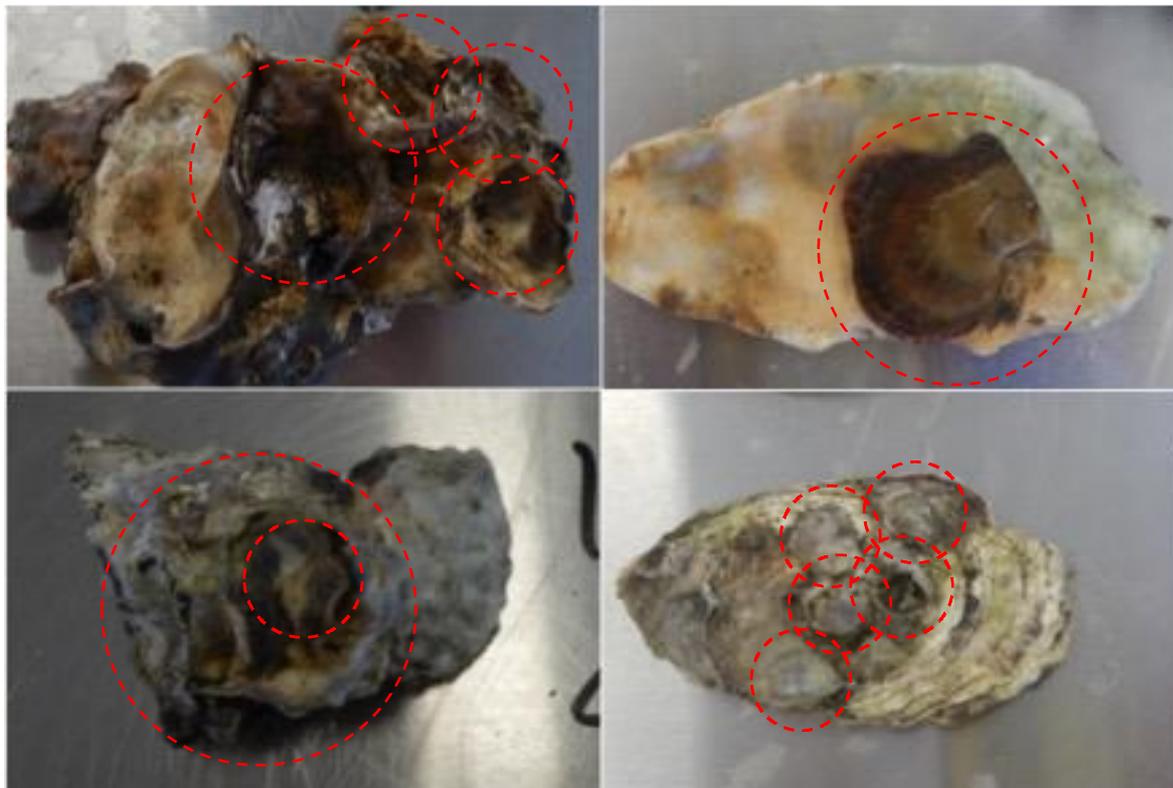
We identified significant oyster settlement during both monitoring events on both necklaces and in the oyster restoration unit bags (Figure 19, Figure S1, Table 4, Table 5). Overall, we identified an average of 387.5 spat/m² in May 2018, 306.1 oysters/m² in November 2018, and 349.9 oysters/m² across both monitoring events (Table 4). Whilst we identified some changes in the densities of oysters at specific restoration sites (Figure S1, Table 5), with some sites showing increased oyster density between sampling events, and others lower oyster density, the overall pattern was for a reduction in oyster density between monitoring events 1 and 2 (Table 4). This change was, however, offset by a significant change in the size-frequency distribution of oyster shells on the reefs (Figure 20, Figure S2). Here oysters increased in size from 14.3 mm (+/- 6.5 mm SD) in May 2018, to 19.1 mm (+/- 8.9 mm SD) in November 2018. Consequently, it is likely that intermediate sized oysters (6-15 mm in length) in May 2018 grew to the larger sizes (i.e. <30 mm) by November 2018, and that the smaller oysters (<6mm) either grew to an intermediate size, or did not survive the winter. Consequently, despite a reduction in overall average density, this was offset by a larger average oyster size during the second monitoring event.

Figure 19 Example images of juvenile oysters growing on shells collected from within the oyster reef restoration units. Spat shown using red dashed circles.

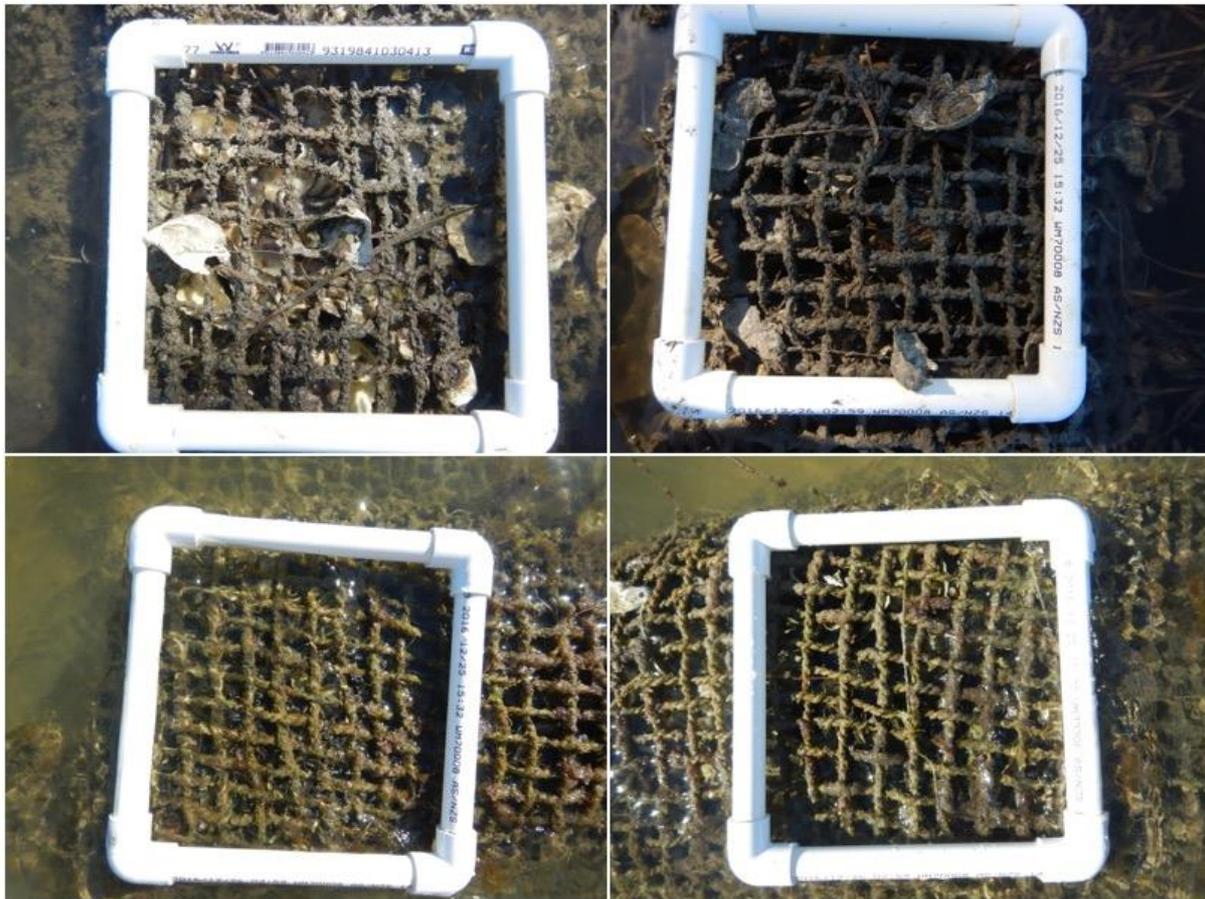
The development of the reefs is in the early stages, therefore 100% of randomly selected oyster shells were still easily moved during both monitoring events. This is unsurprising as the development of stable biogenic matrix was not expected within the first year, and the performance objective is to be assessed in year 3. Despite this, no loose oyster shells were lost from in-tact bags. We anticipate, however, that given the positive indications of spat recruitment and oyster growth, that this performance criteria will likely be achieved in the coming years. We were, however, able to use the quadrat samples (see figure 21) to show

that there has been no significant degradation of the coir mesh, that it is still strong, and that the gauge of the rope has not been narrowed by any natural decomposition as yet.

Figure 21 Example images of quadrat photos taken on oyster reef restoration units, here at reefs 13 (top row) and 16 (bottom row). We did not identify any significant growth of invertebrates on the outside of the oyster reef units, but there was also no significant degradation of the coir mesh noted.

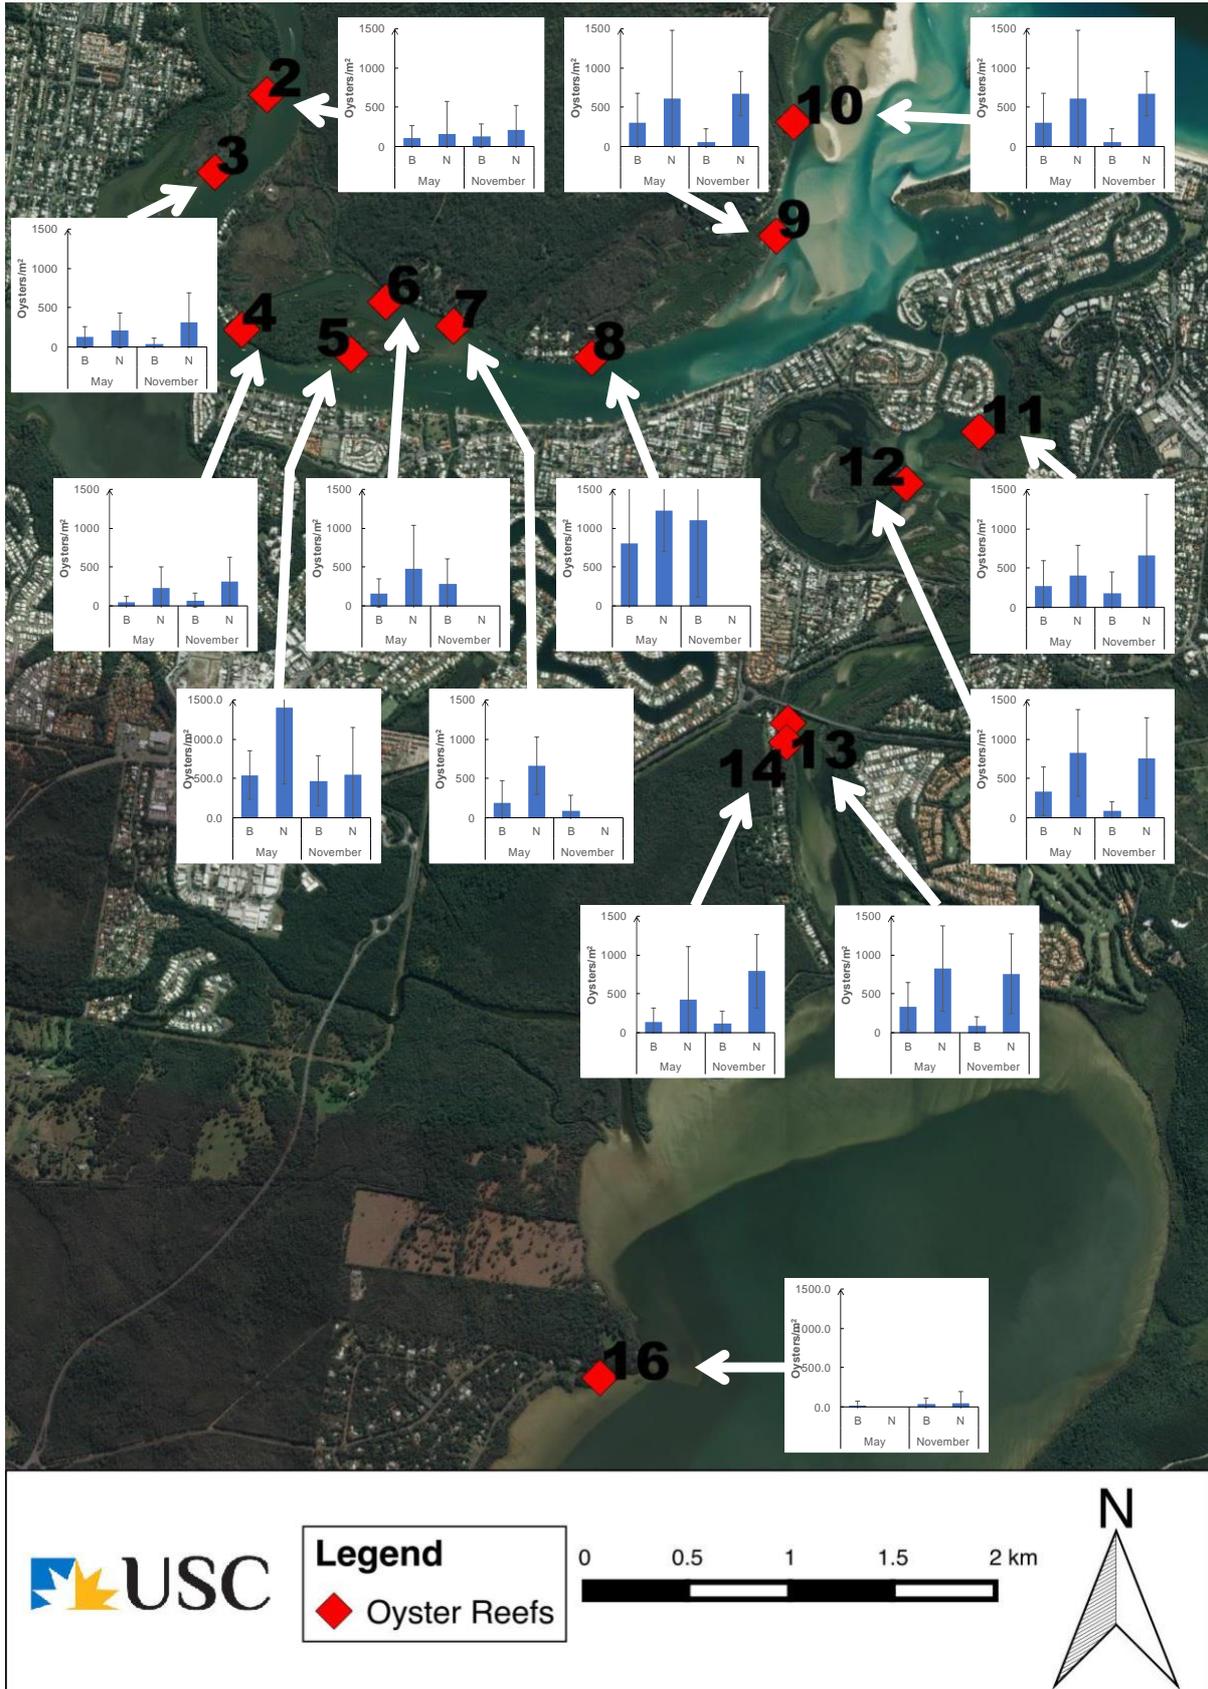
Figure S1 Map of oyster reef restoration sites with average (+/- SD) values for oyster density during May and November 2018 monitoring events in the oyster reef bags (B) and on the oyster necklaces (N).
