Our Reference: 1533L2020.1

**RE: Noosa Oyster Reef Restoration – 2<sup>nd</sup> Annual Monitoring Report 2019**

Please find attached the second annual assessment of the success of the Noosa oyster reef restoration trial, which includes assessments completed at the end of the second spat settlement season in May 2019 and start of the third spat settlement season in October 2019.

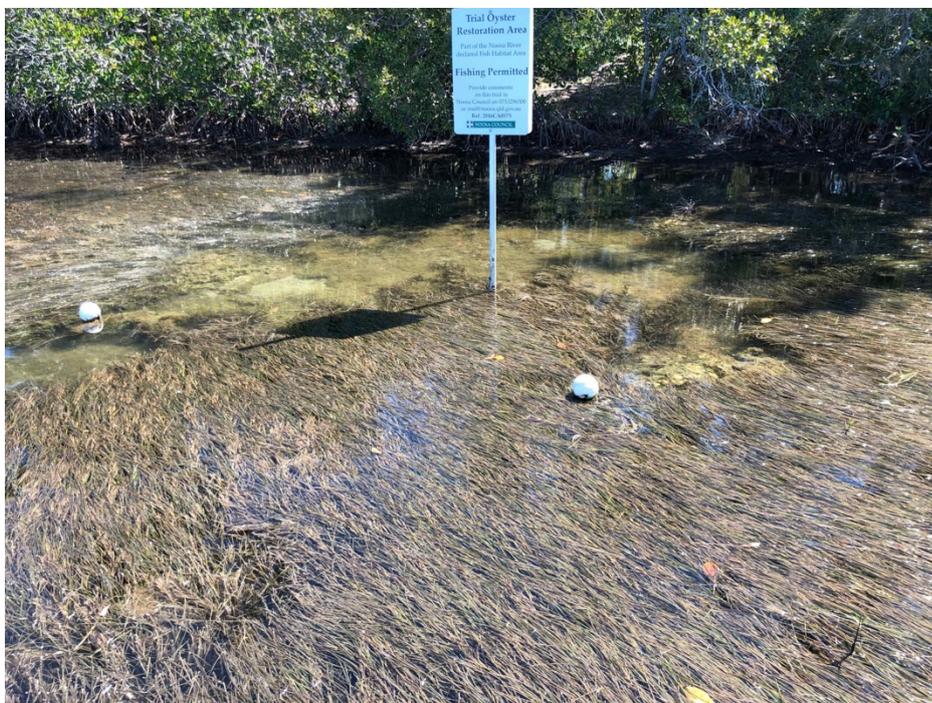
Figure 8 Dense seagrass and restoration units at Site 14 in October 2019

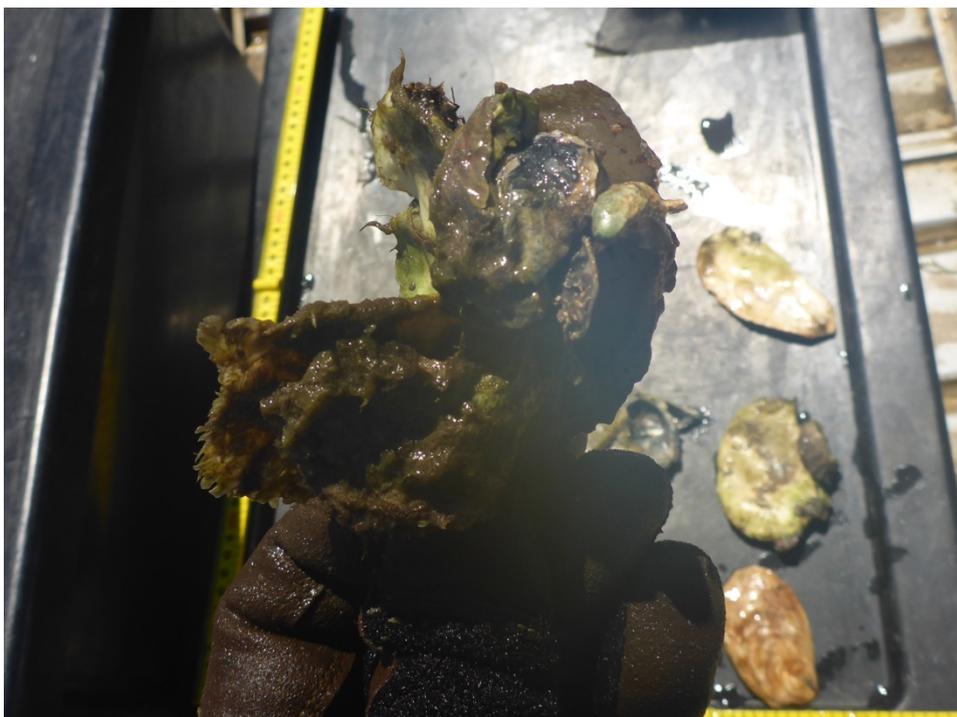
A variety of other sessile invertebrates had recruited to several of the restoration units including other shellfish (hairy mussels, pearl and leaf oysters), sponges and ascidians. These sessile invertebrates are critical for consolidating the oyster shells into clumps (Figure 13 & Figure 14). In October 2019, three sea hares (*Aplysia* sp.) approximately 15 to 20 cm long were also observed grazing on macroalgae growing on the reefs at Site 13 (Figure 15).

Figure 13 Oyster shell consolidated by encrusting sponges and oysters at Site 12
