Noosa Estuary Trial Oyster Reef Restoration

Final Monitoring Report

Prepared for: Noosa Council

**Prepared by Ecological Service Professionals Pty Ltd on behalf of Noosa Biosphere
Reserve Foundation**

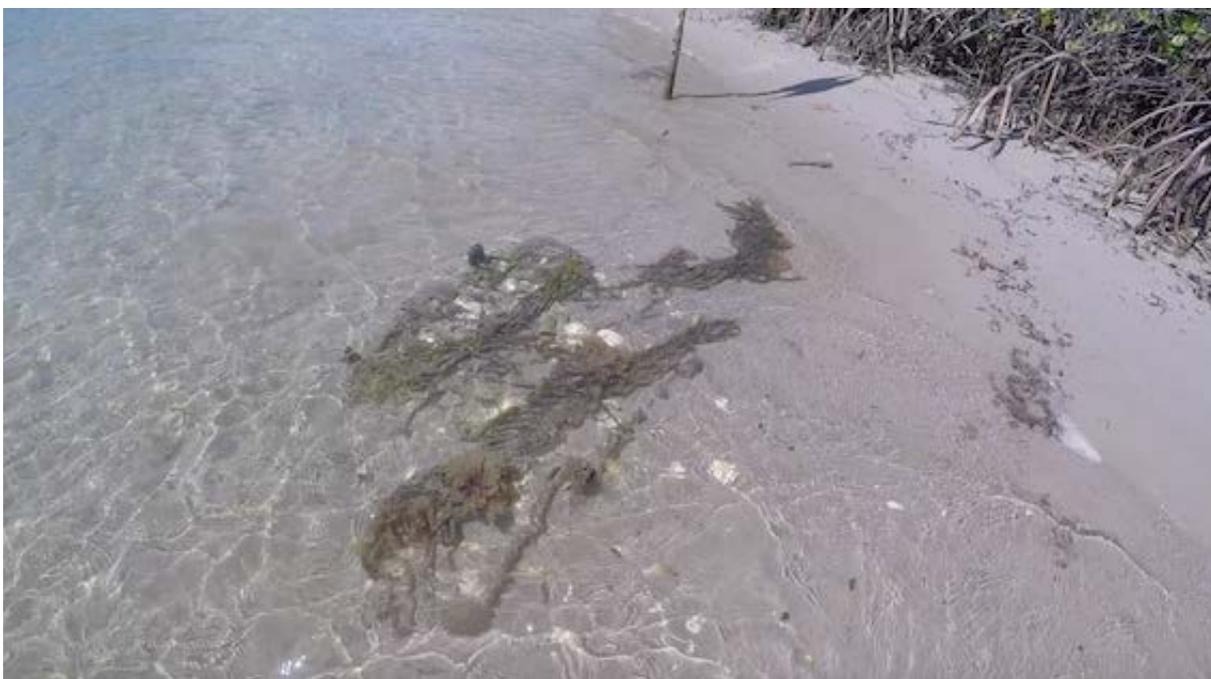
In February 2019, it was decided that 10 of the 14 reefs initially deployed should be removed, due to substantial incidental damage from boat strike and other damage (all reefs removed were from within the main Noosa River channel) (Gilby et al. 2019). An example of the damage caused to reefs at Site 10 is provided in Figure 1. As identified in the report, the restoration units were removed, and all shell and coir mesh disposed of at the Noosa Council waste disposal site in accordance with State Permitting and Approval requirements (refer to Section 4). Pre- and post-deployment photos, as well as pre- and post-removal photos are provided in Appendix A.

Figure 1 Example of damage caused by a boat at Site 10 in January 2019 (reef now removed)

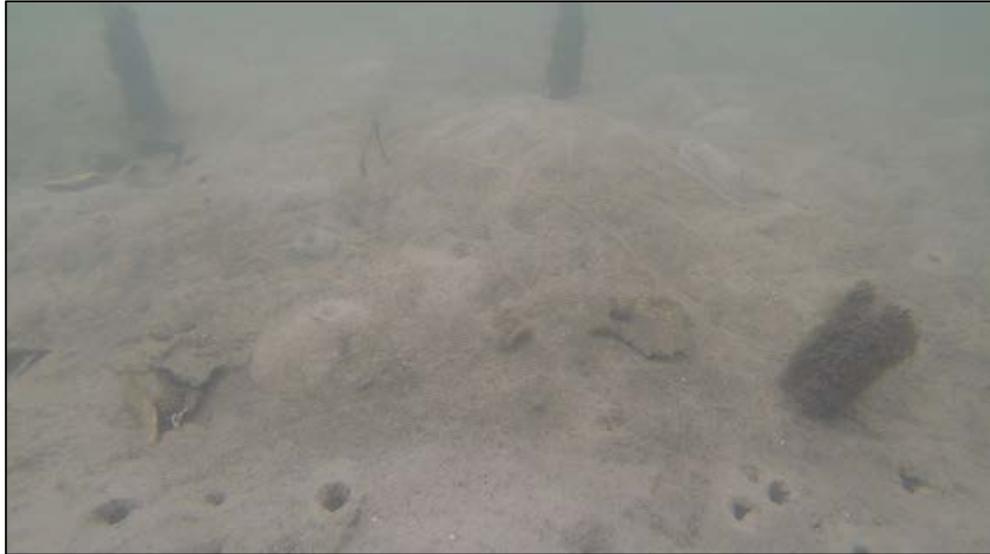
Figure 3 Oyster reef and wooden stakes at Site 12 in September 2020

The reef areas remained within the RAA and moved less than 1 m within the 3 year trial period. Without the coir mesh the reefs collapsed; however, there were insufficient tidal currents or freshwater flow to shift the shell outside the RAA.

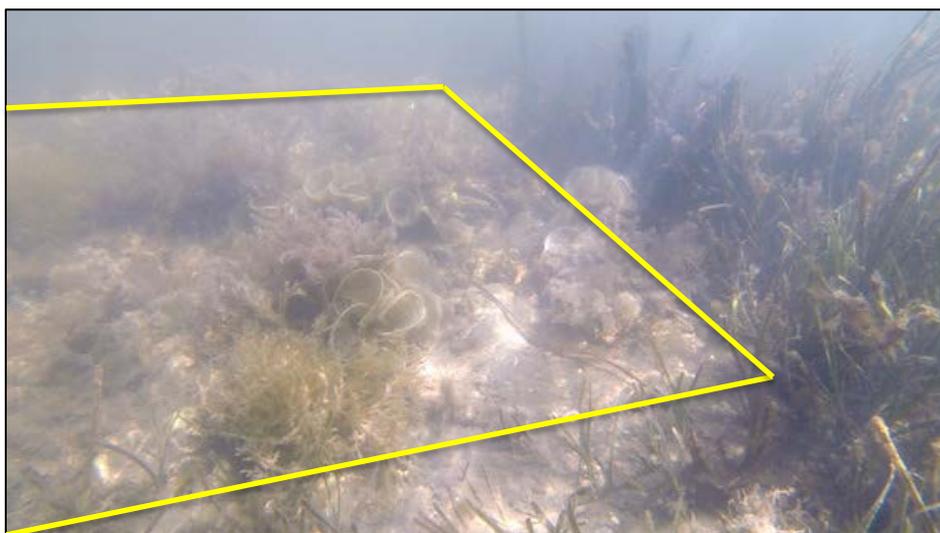
The restoration area at Site 14 was nestled between existing seagrass beds, which had grown up next to the restoration units. The reefs at this site remained elevated above the sediment surface, although no longer intertidal (within the optimal zone of highest spatfall). They represented a good aggregation of shell cultch with oyster spat and macroalgae growing on it. With additional time, these shell aggregations are expected to consolidate further and become a functional habitat type within the existing seagrass beds, contributing to the mosaic of habitats found there (Figure 4). The growth of marine plants around the oyster reefs further reduced accumulation of fine sediment on the shell cultch, but did not prevent it from sinking into the sand until it reached an underlying gravel layer below.

Figure 4 Oyster shell patches covered by macroalgae (*Padina* and *Laurencia*) at Site 14 showing proximity to seagrass in 2020*

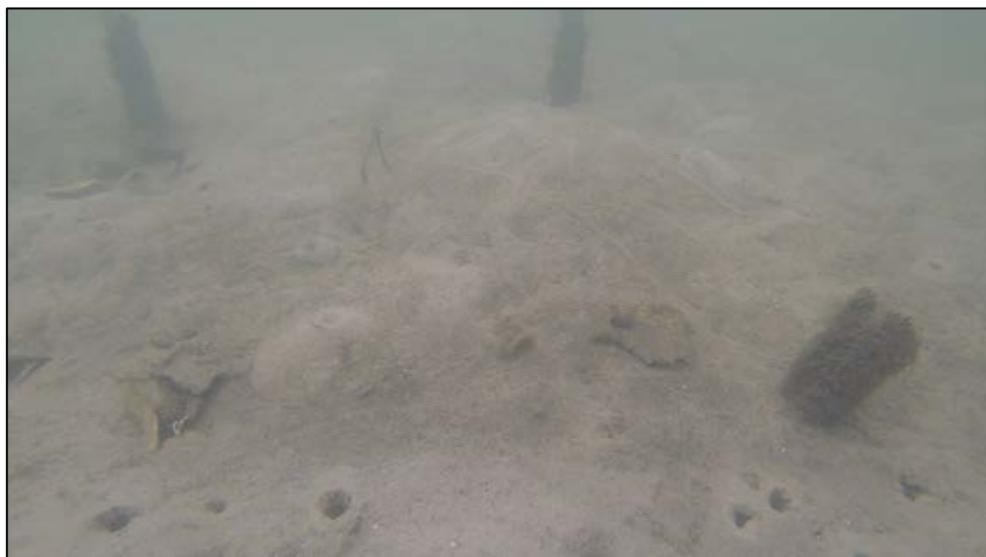
Figure 5 Restoration patch subsided under sediment at Site 12 in September 2020

OUTCOME: Restoration units have been removed from Site 12 and the area rehabilitated – refer to photos pre- and post-removal provided in Appendix A.

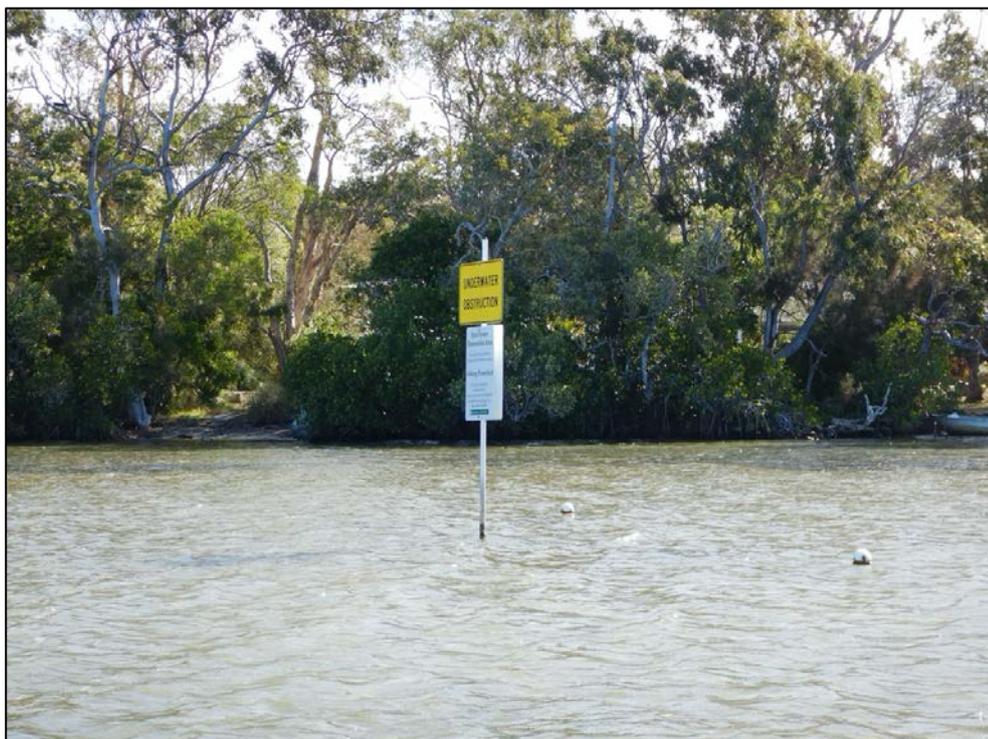
As the reefs had been almost completely buried in September 2020, the shell patches were removed by hand and the area remediated back to the pre-deployment condition (Figure 22). Subsequent visual assessment of the area after reef removal has demonstrated no ongoing influence of the reefs or removal of the restoration units or signage (Refer to Section 4).

Figure 7 Oyster reef restoration area at Site 13

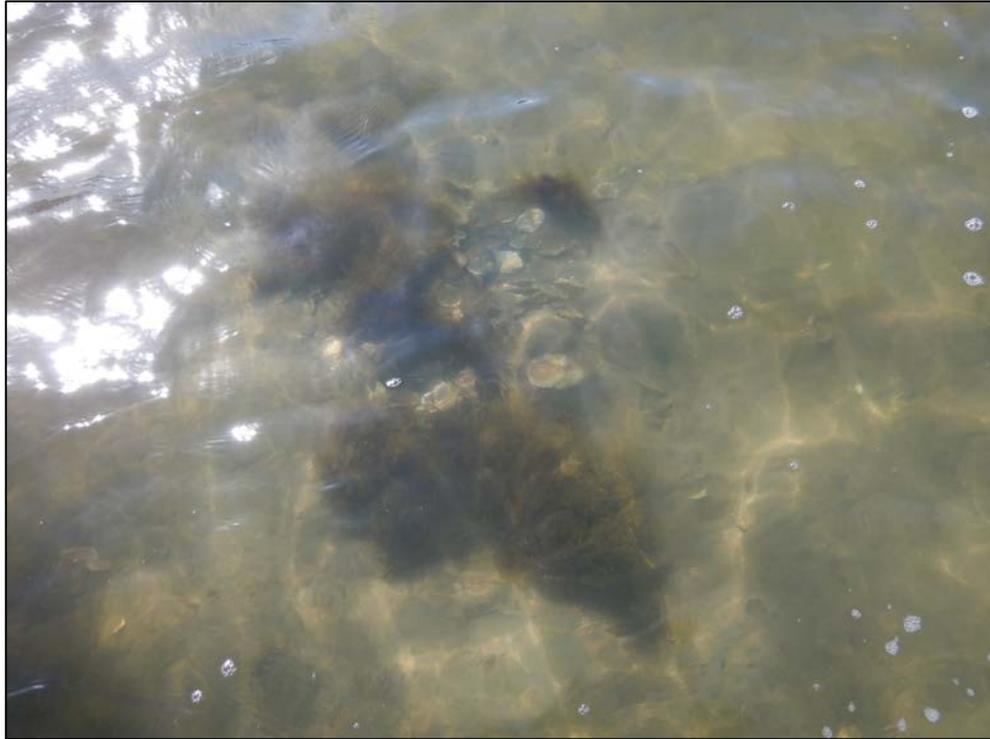
Figure 8 Oyster reef covered with macroalgae at Site 13 in September 2020

OUTCOME: Restoration units have been removed from Site 13 and the area rehabilitated – refer to photos pre- and post-removal provided in Appendix A.

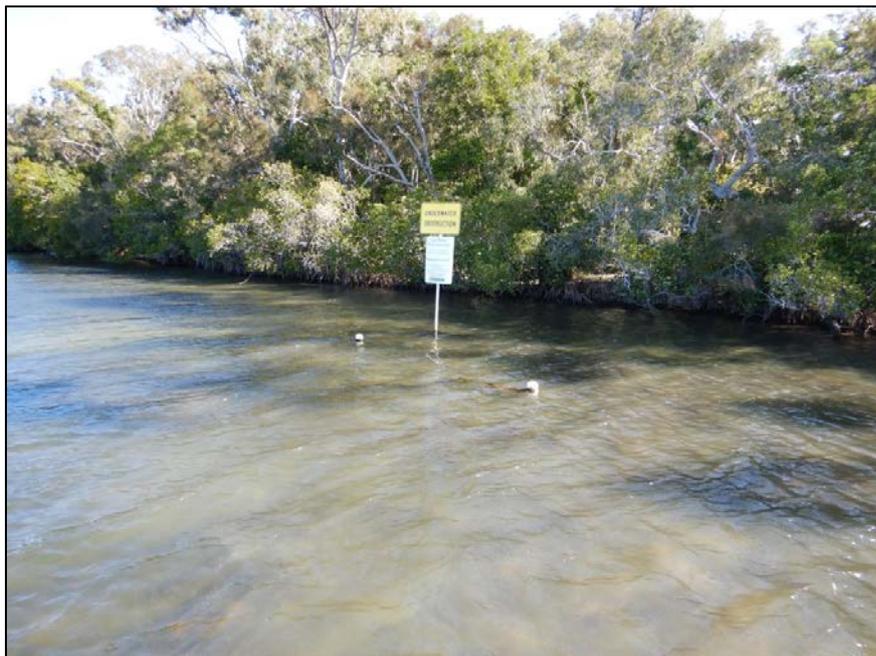
The remaining shell from the restoration units had largely been consolidated by foliose macroalgae and sponges (Figure 4). In October 2020, the restoration units at this site were surrounded by established seagrass beds (dense beds of long blade *Zostera muelleri subsp. capricorni*) (Figure 4), which had increased in extent since deployment, particularly infilling over bare sediment up to the edge of each restoration unit (Figure 11; refer to Section 3.7 Table 3). Numerous juvenile fish were observed using the reef restoration units and moving between them and the surrounding seagrass in both May and September 2020.

The reefs at this site remain relatively intact although have lost approximately 20 cm of vertical relief. In our opinion they currently represent the beginnings of small oyster reef patch. The reef is similar in morphology to remnant reefs found elsewhere in Southeast Queensland, including the leaf oyster reef downstream of this area, where there is an aggregation of small oysters, other invertebrates and macroalgae growing on layer of shell cultch over the sediment surface (Figure 4). These restoration areas have met several of the objectives of the trial and therefore we believe they should remain as part of the natural fish habitat available in the estuary and all associated signage removed.

Figure 10 Oyster restoration Site 14 in September 2020

OUTCOME: Reefs remain at this site. Signage still to be removed.

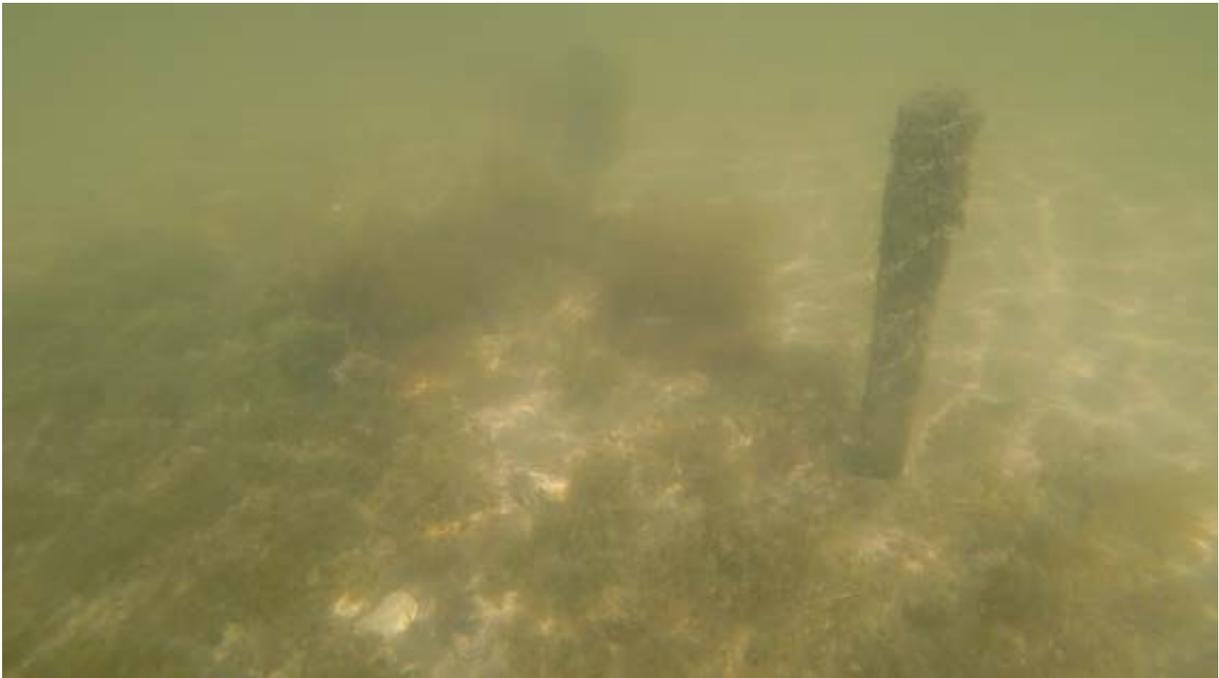
In September 2020, the reef units at Site 16 had not moved substantially from their original position (<0.5m), although due to breakdown of coir mesh observed in October 2019, the oysters contained in the bags had spread to the northwest due to wind driven wave action and become buried under the fine sand. There was a high cover of macroalgae observed on bags at this site in October 2019 and again in September 2020 (Figure 12); although, following burial by sand in September 2020, the shell and much of the macroalgae was largely absent and just covered the surface in some sections.

Figure 12 Oyster reef covered with macroalgae at Site 16 in September 2020

Due to the almost complete burial of reefs, they were removed by hand and the sediment in the area remediated back to the pre-deployment condition (Refer to Section 4). Subsequent monitoring of the area after reef removal has demonstrated no ongoing influence of the reefs or from shell removal (Appendix A).

OUTCOME: Restoration units have been removed from Site 16 and the area rehabilitated – refer to photos pre- and post-removal provided in Appendix A.

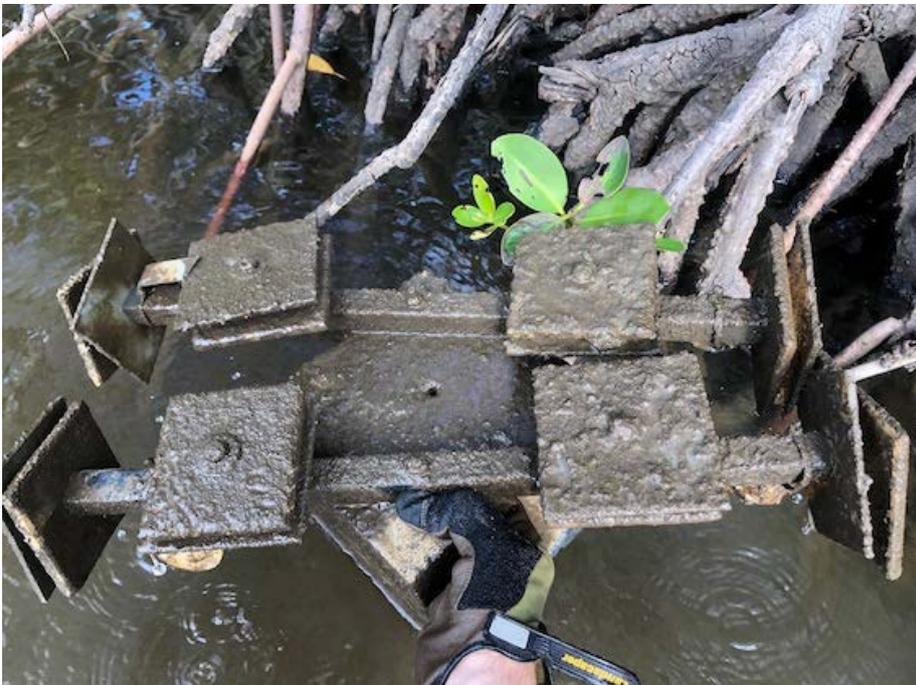
The settlement of oysters at some sites was highly variable during the 2019-2020 spat fall period as measured by recruitment onto settlement plates at sites 12 and 13, which differed in the density of rock oysters on different substrates and surface orientations deployed intertidally, with average density ranging from 25 to 4000 oysters.m⁻² (McDougall & Walker 2020). In particular, there was a high covering of fine sediment on the upper surface of settlement plates, which prevented settlement or smothered recently settled oysters (Figure 14).

Figure 14 Sediment covering intertidal settlement plates at Site 12 in April 2020

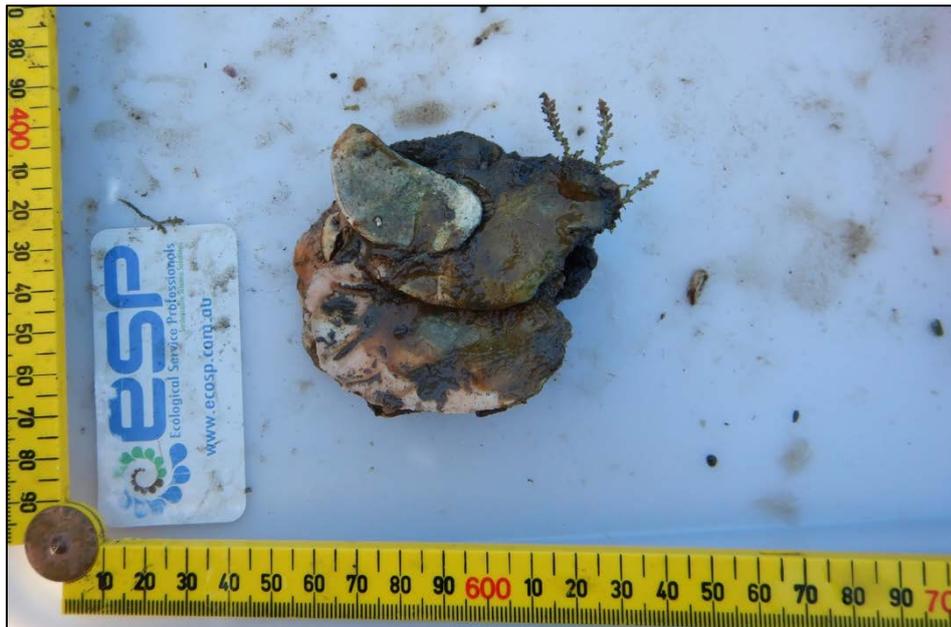
Figure 17 Oyster shell consolidated by encrusting sponges, algae and oysters at Site 14

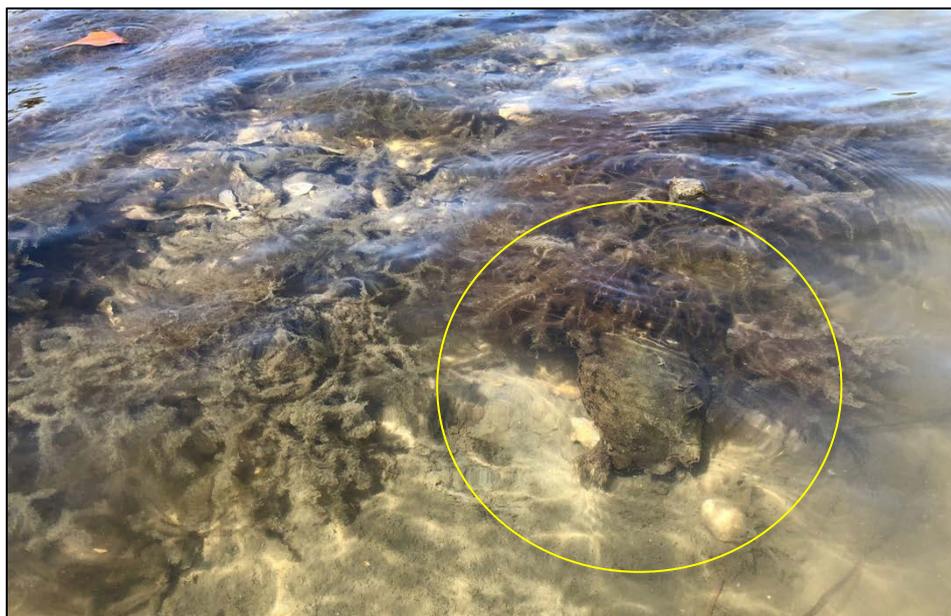
Figure 18 One of three large sea hares (*Aplysia dactylomela*) consuming algae on oyster reefs at Site 13 in October 2019

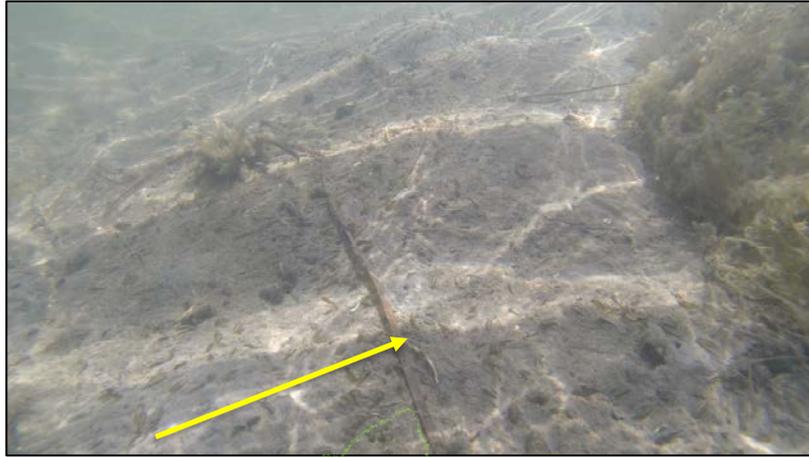
In May 2019, the pioneer seagrass species *Halophila ovalis* was observed growing within the RAA area at site 13 (Figure 20). Prior to reef deployment, this area was an unconsolidated mobile sand bank with no seagrass present. There was a reduction in the cover of the *Zostera* bed along the shoreline between July 2017 and May 2018, followed by a large increase, which has remained relatively stable between 2019 and 2020 (Figure 21; Table 3 & Table 4). The causal mechanism for this broader change is unclear; however, this area is adjacent to a stormwater outlet and the reduction in seagrass cover is likely due to external environmental factors, not the placement of restoration structures at site 13 or 14. We completed an additional historical assessment to examine the change in seagrass coverage within 50 metres of the restoration area using imagery sourced from Queensland Globe between 2015 and 2019, and found that the coverage of seagrass adjacent to Site 13 peaked in 2017, then declined by approximately half the area between 2017 and 2018 (Table 3). In 2019, the area covered was similar to that assessed in 2016 (Table 3). In contrast, at site 14 there has been an increase in coverage of seagrass (and seagrass wrack) adjacent to the restoration structures (Table 3 & Table 4).

Figure 20 Sparse *H. ovalis* growing adjacent to the oyster reefs at Site 13 in September 2020

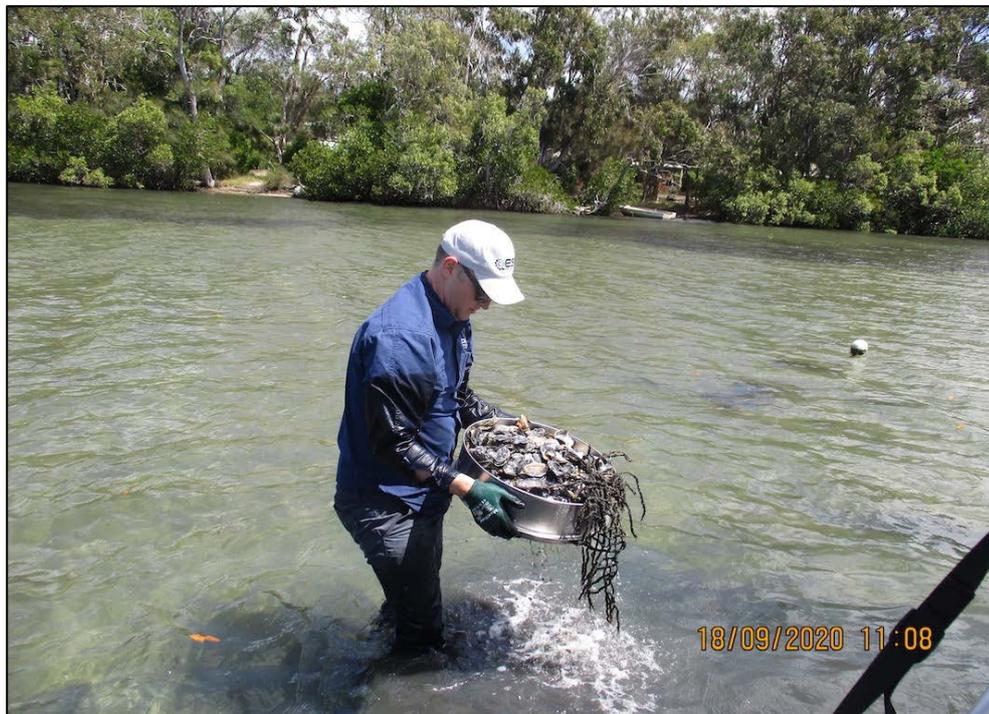
Figure 22 Removal and sieving of oyster shell by hand at Site 13 (18 September 2020)

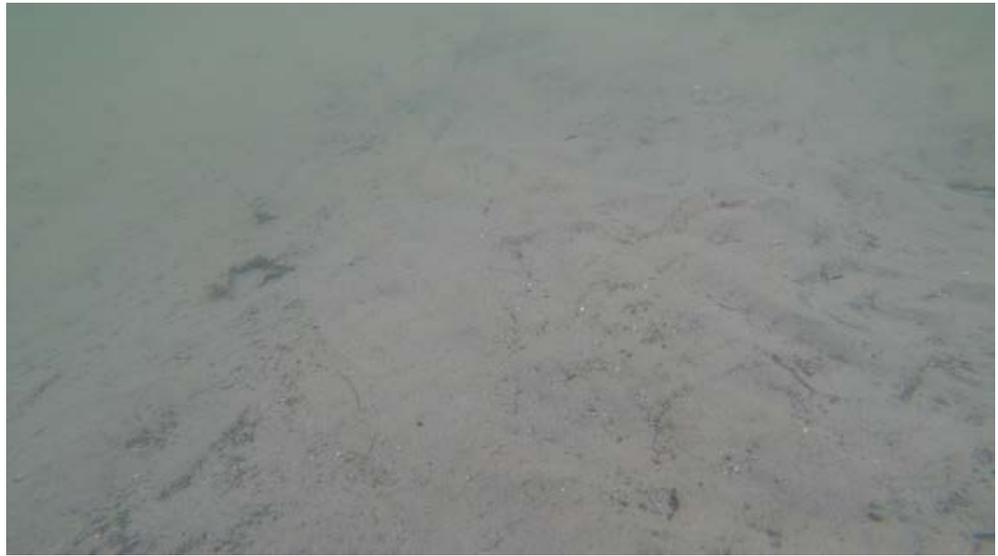
Site 14 – Reefs and signage has not been removed at this site
Post
removal

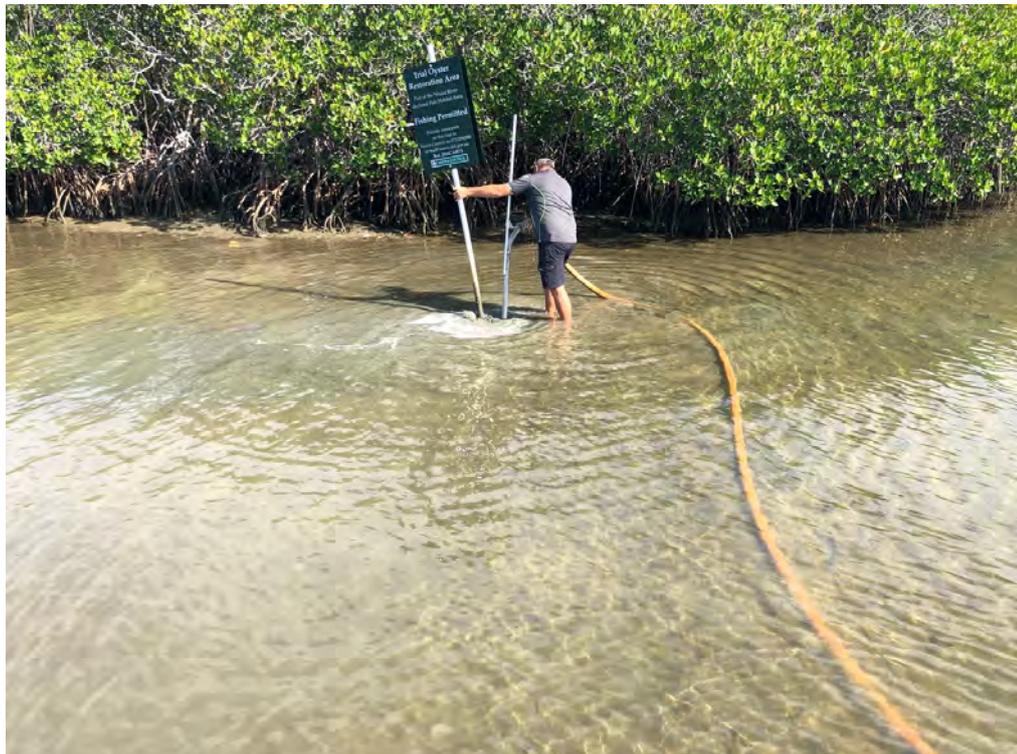
Figure 2 Removal of signpost by hand using waterjet over bare sand at site 2

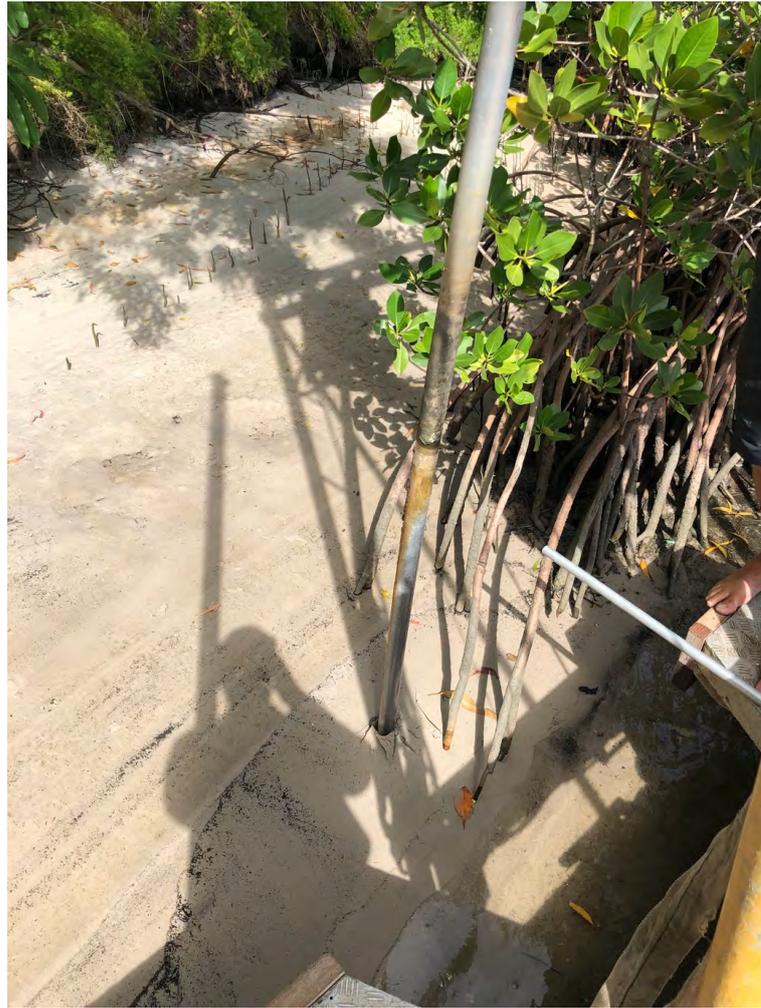
Figure 3 Manual extraction of signpost adjacent to *Rhizophora* mangrove at Site 11.
