## Healthy Waterways and Catchments

# Keeping It In Kin Kin – Applying LiDAR Change to Identify Erosion Hotspots

**DRAFT November 2016**

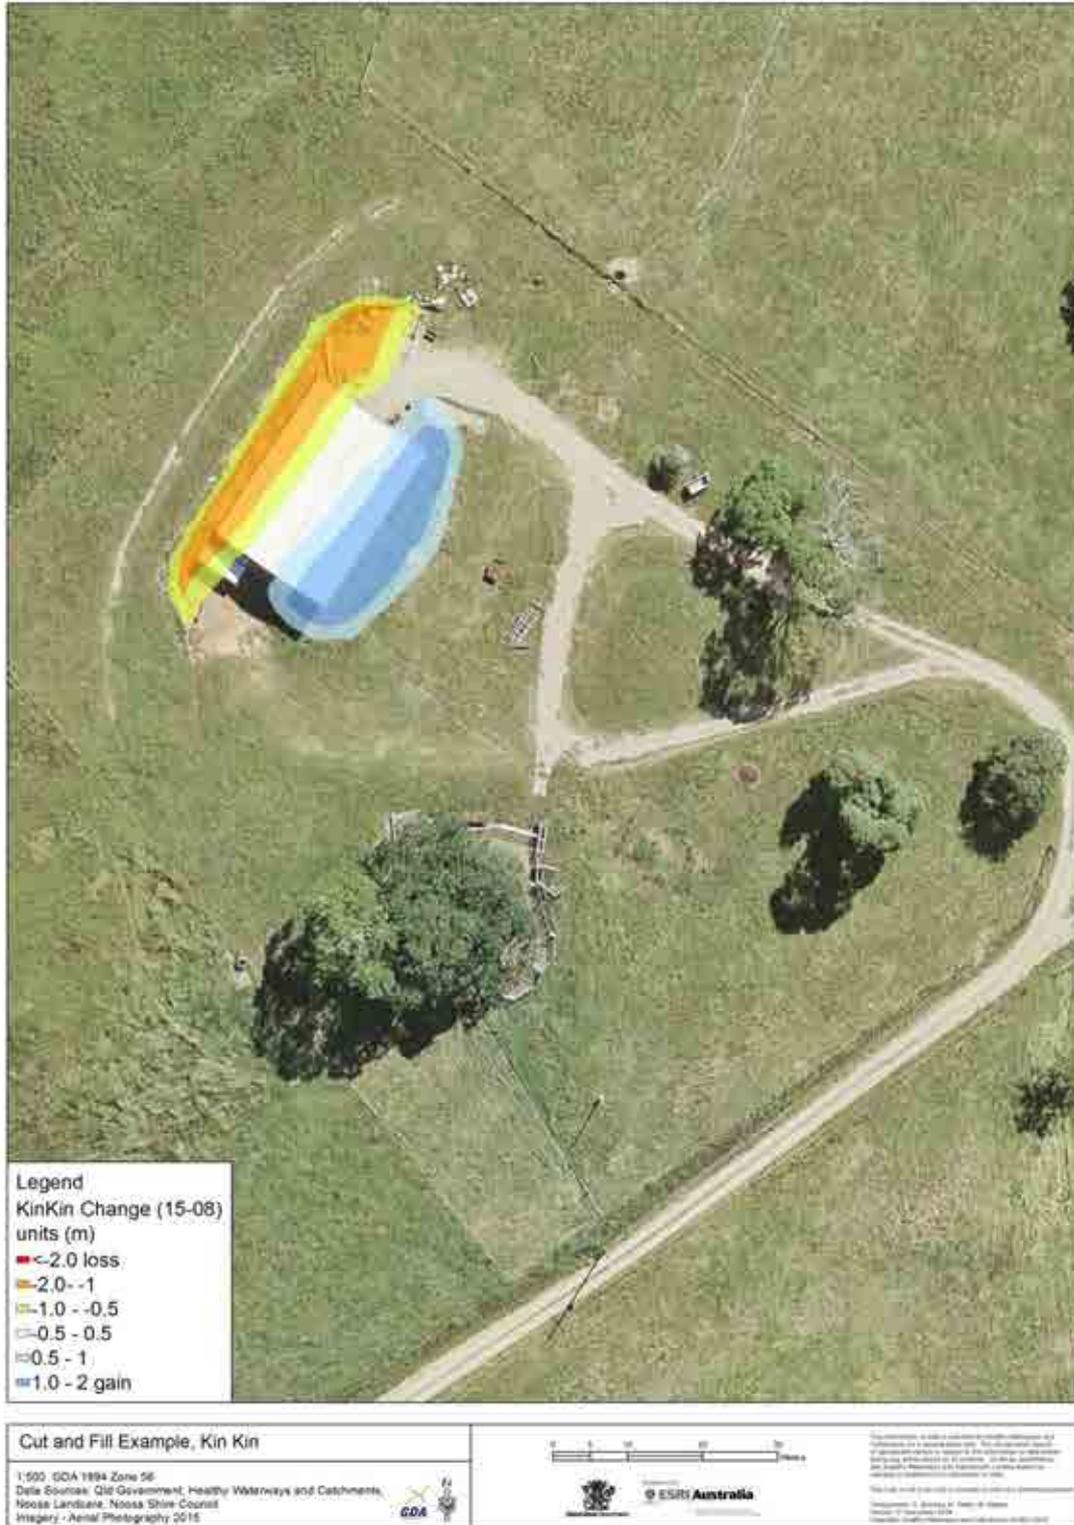
**Map 2: Cut and Fill example showing loss of elevation where soil has been removed on slope and then used as fill as gain in elevation to create a level pad for shed/house.**

Over 90% of observed LiDAR Change values were within the 0.5 - 2.0 m range and in terms of erosion rates for the Noosa River Catchment are more realistic. Cut and fill activities for housing and infrastructure, and topographic features (steep embankments and waterfalls) were observed through aerial photography in the 2.0 - 5.0 m and > 5.0 m LiDAR Change ranges. A moderate confidence level was given to the 2.0 – 5.0 m range.

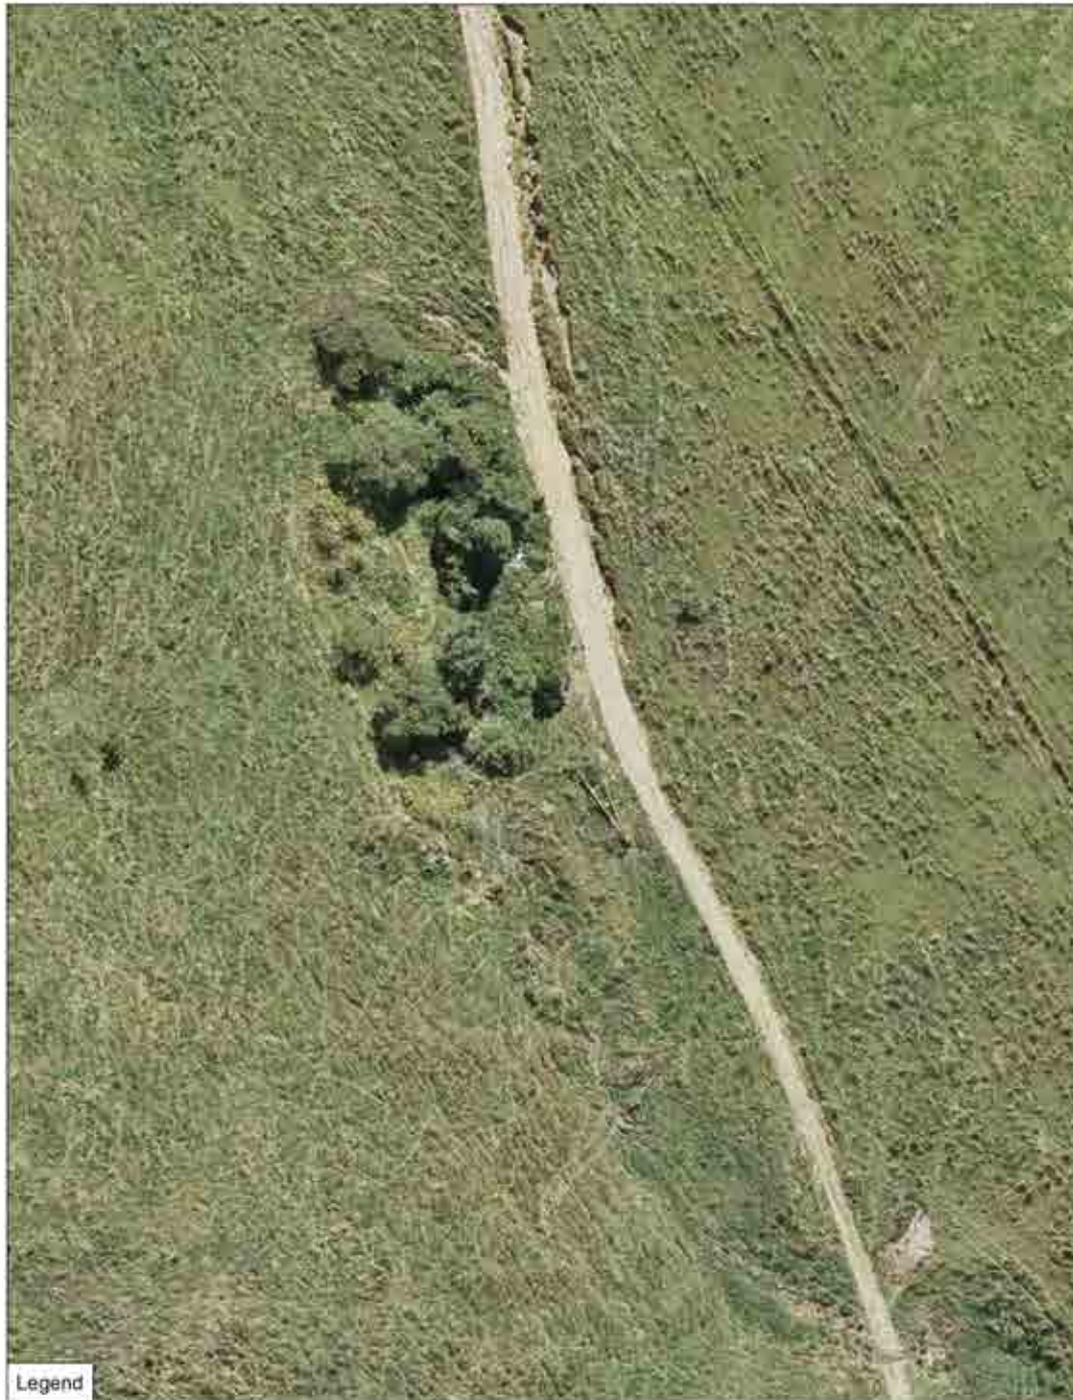
**Map 3a: Aerial photography 2015 showing Erosion Type of "gully erosion" (not visible)**

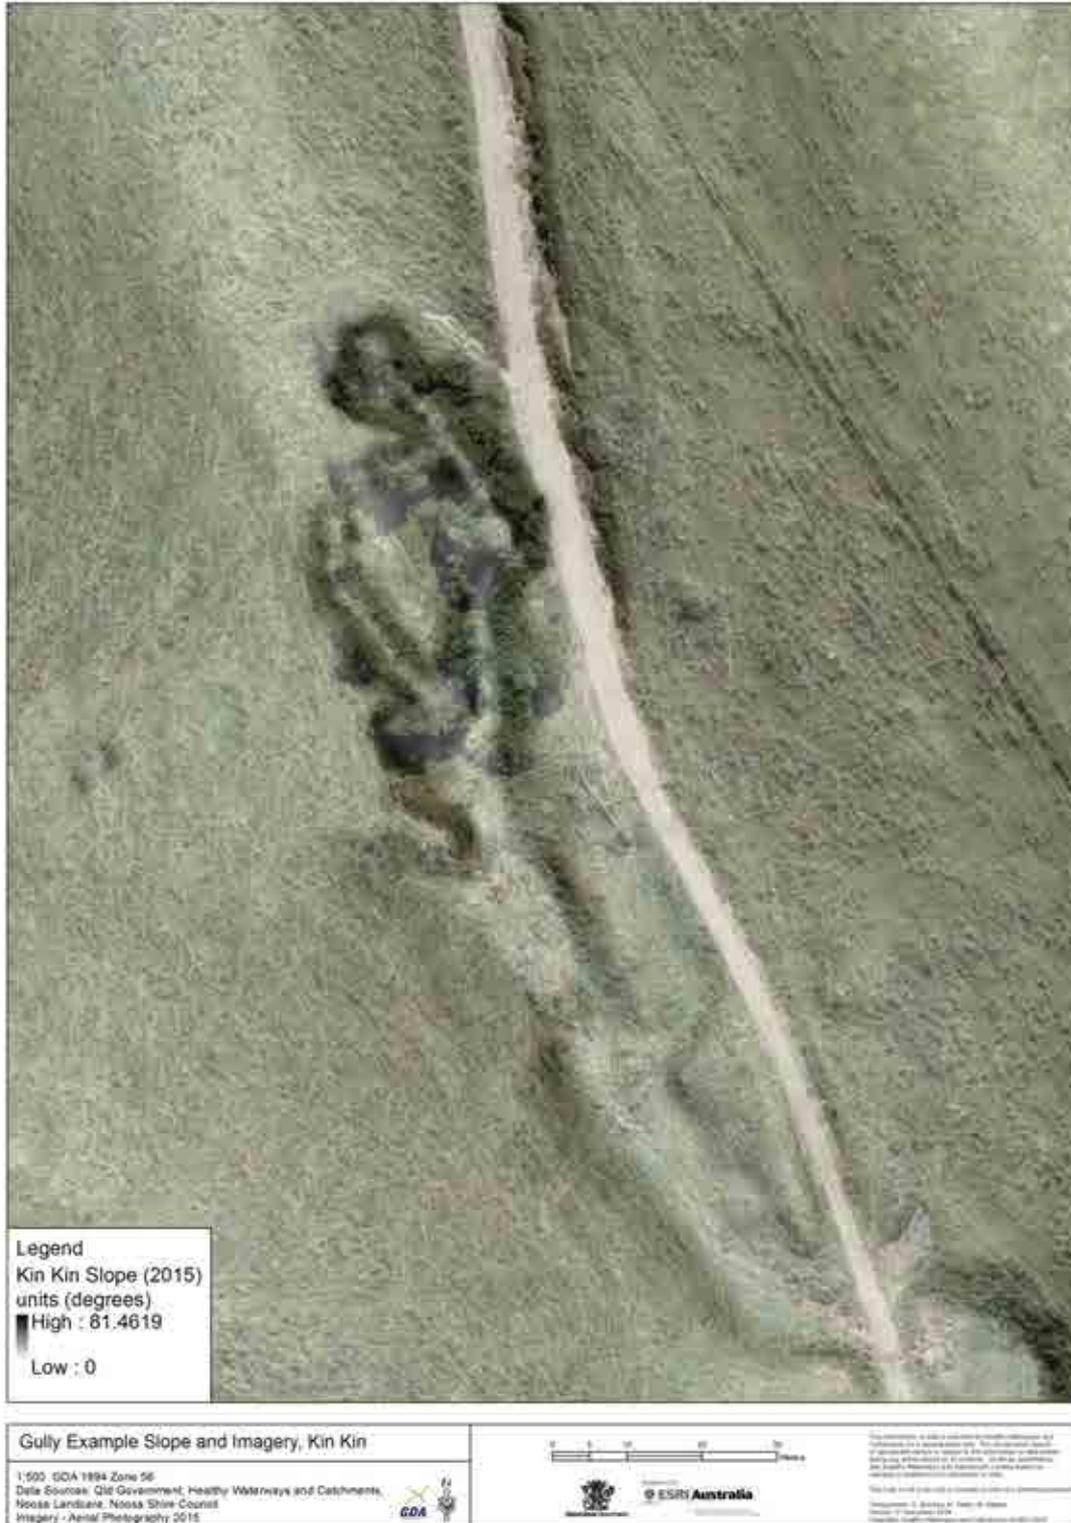
**Map 3b: LiDAR slope showing Erosion Type of “gully erosion” where dark slope represents steeper areas and light slope are flatter areas**

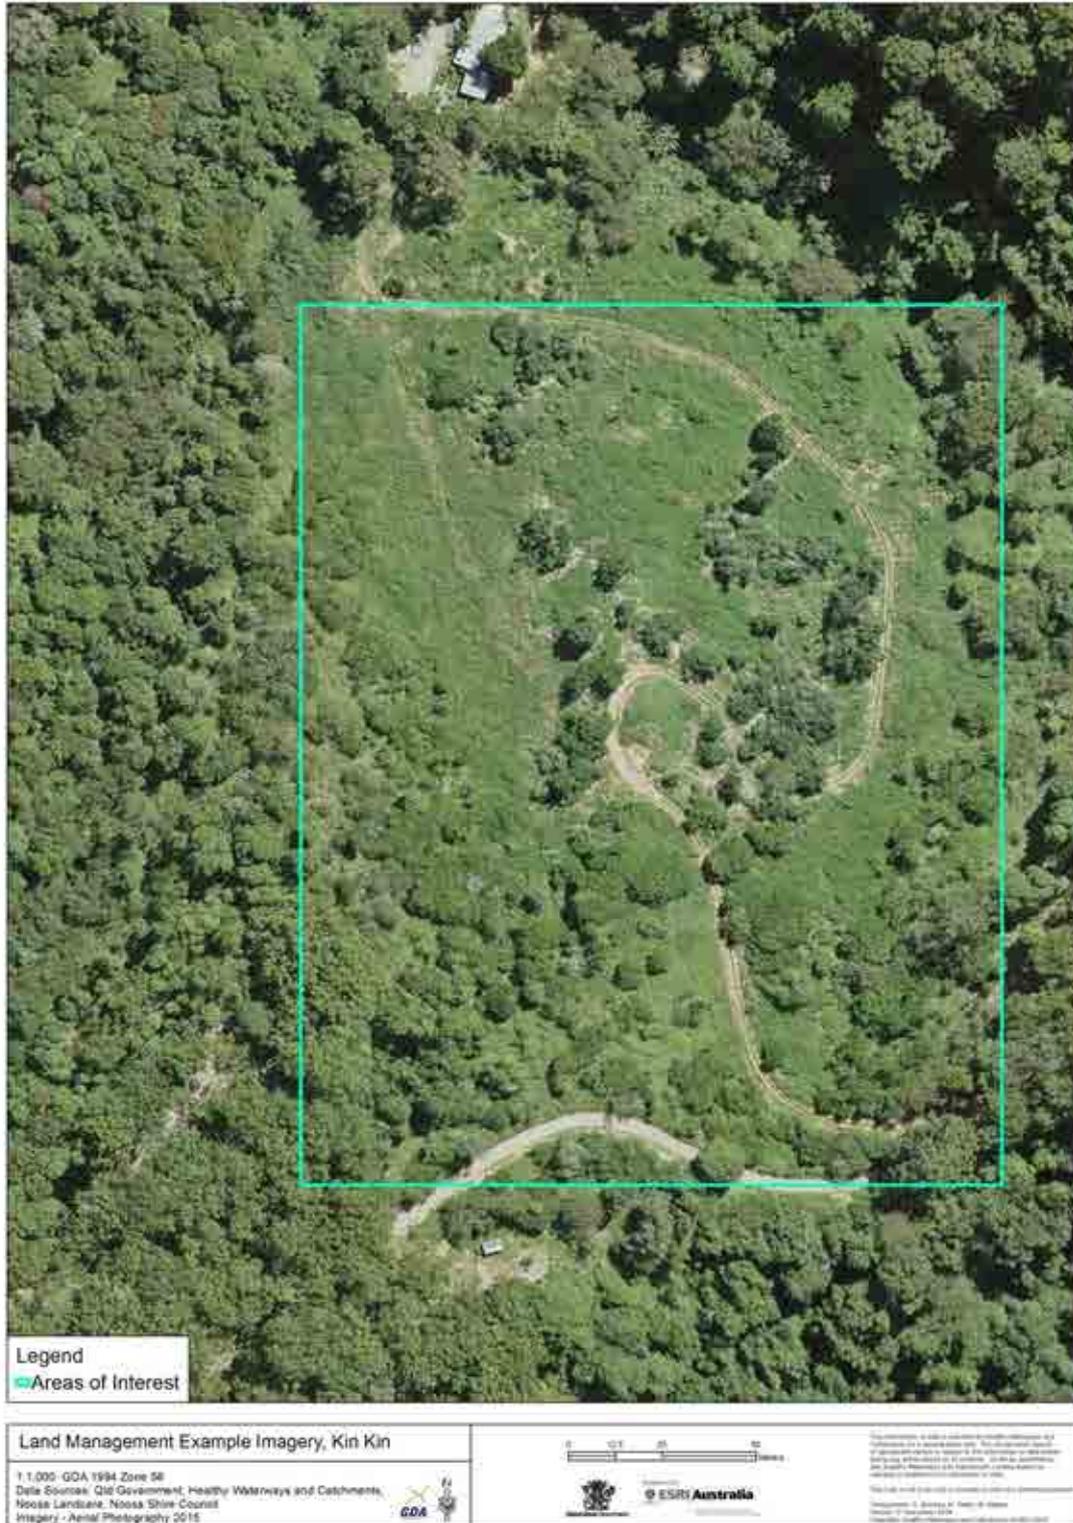
**Map 4a: Aerial photography 2015 of Erosion Type “Land Management” (disturbance and weeds)**

**Land Management – Disturbance and Weeds:** This category was included to capture erosion processes caused by disturbance and weeds. The LiDAR DEM Change Map was showing soil loss associated with tracks, general land disturbance and areas infested with weeds. Further ground-truthing required to classify into other erosion type categories.

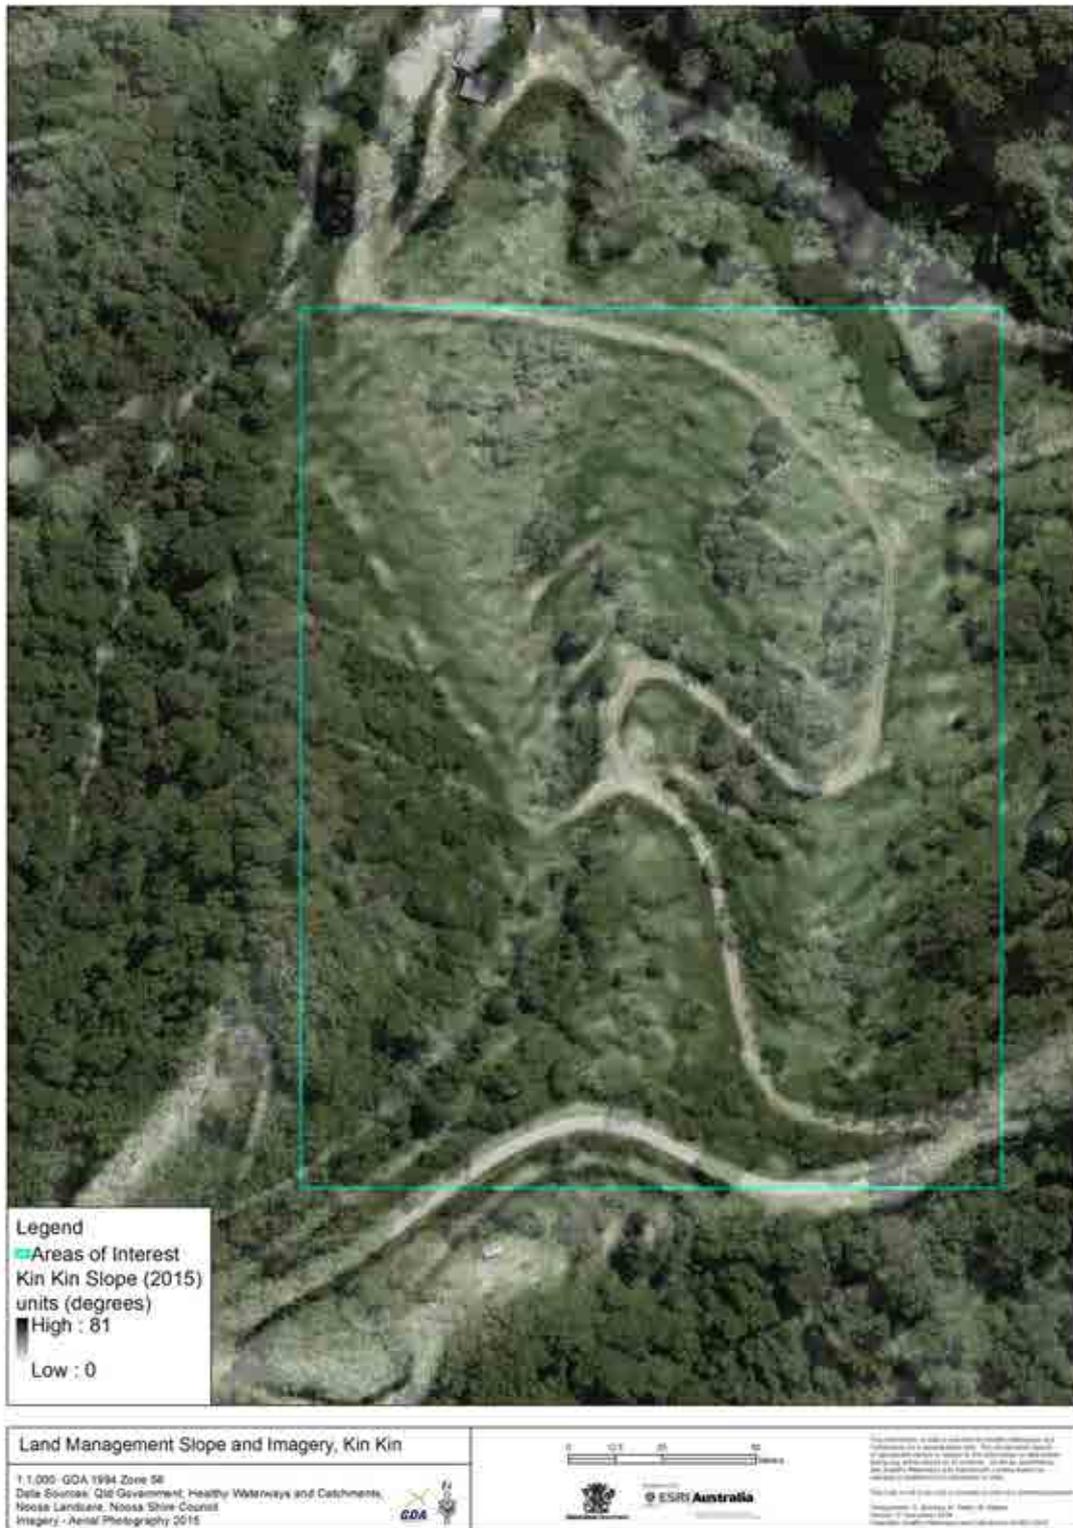
**Map 4b: LiDAR slope showing Erosion Type of “Land Management” highlighting tracks and general disturbance on steeper slopes. The lidar slope is generally showing unstable conditions on previously cleared lands with potential weeds as regrowth**

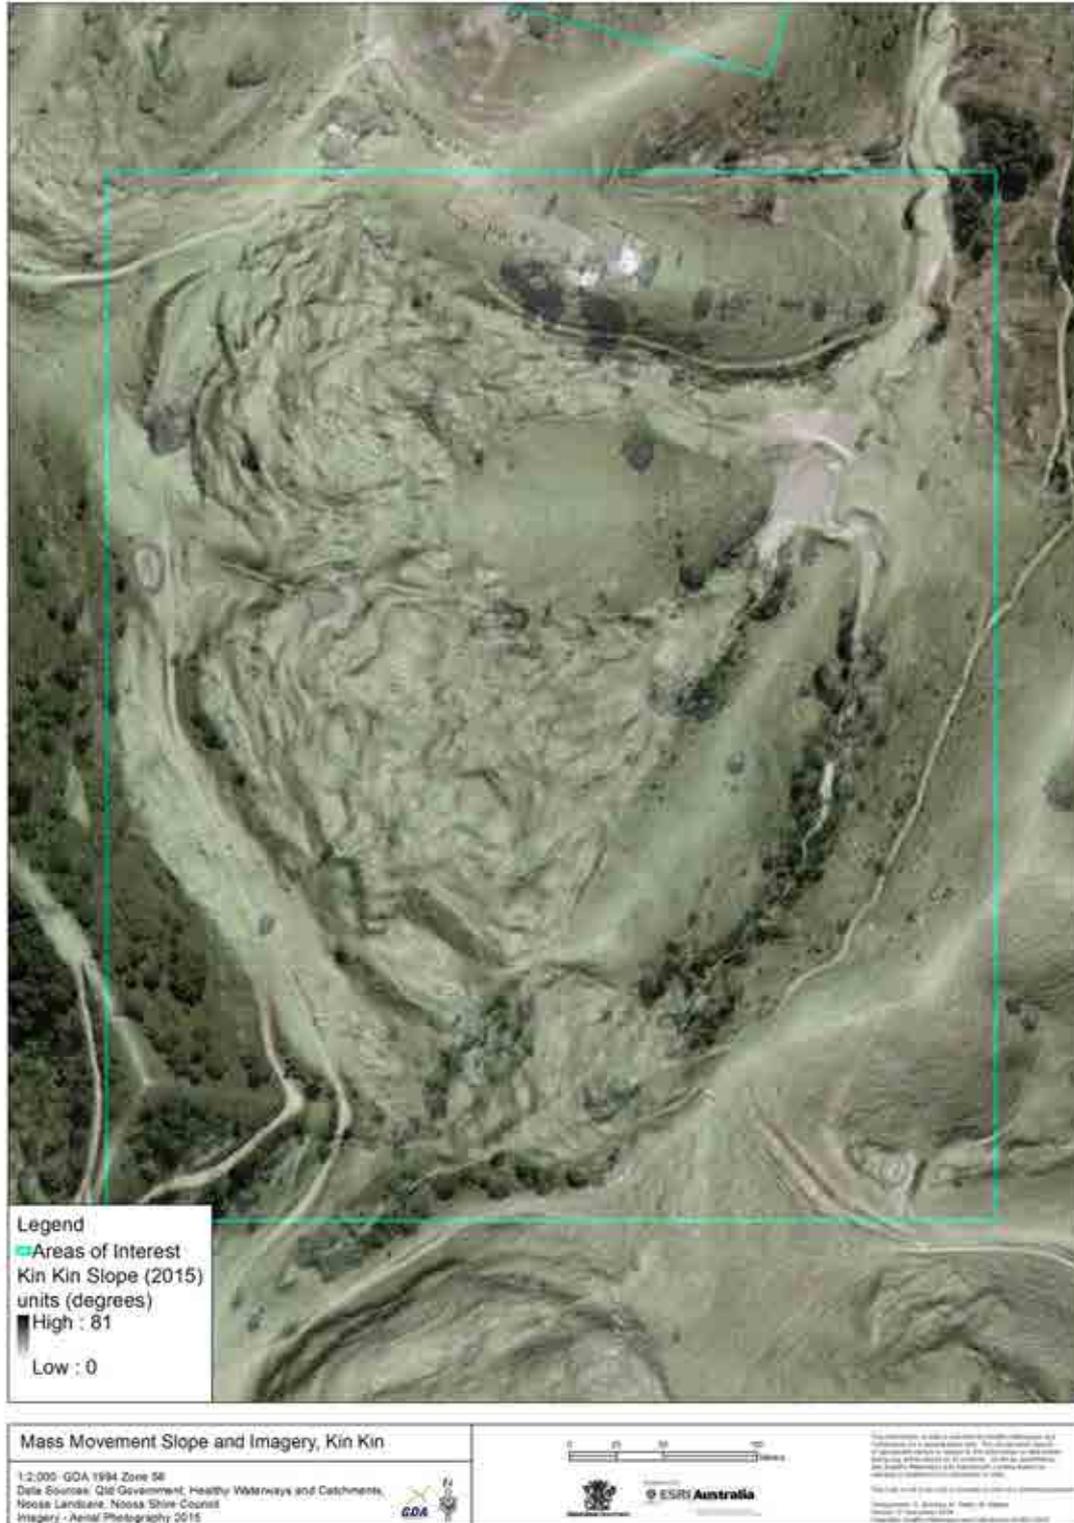
**Map 5b: LiDAR slope showing 2 distinct areas of Erosion Type “Mass Movement” highlighting rippling affect as soil slumps down the slope**

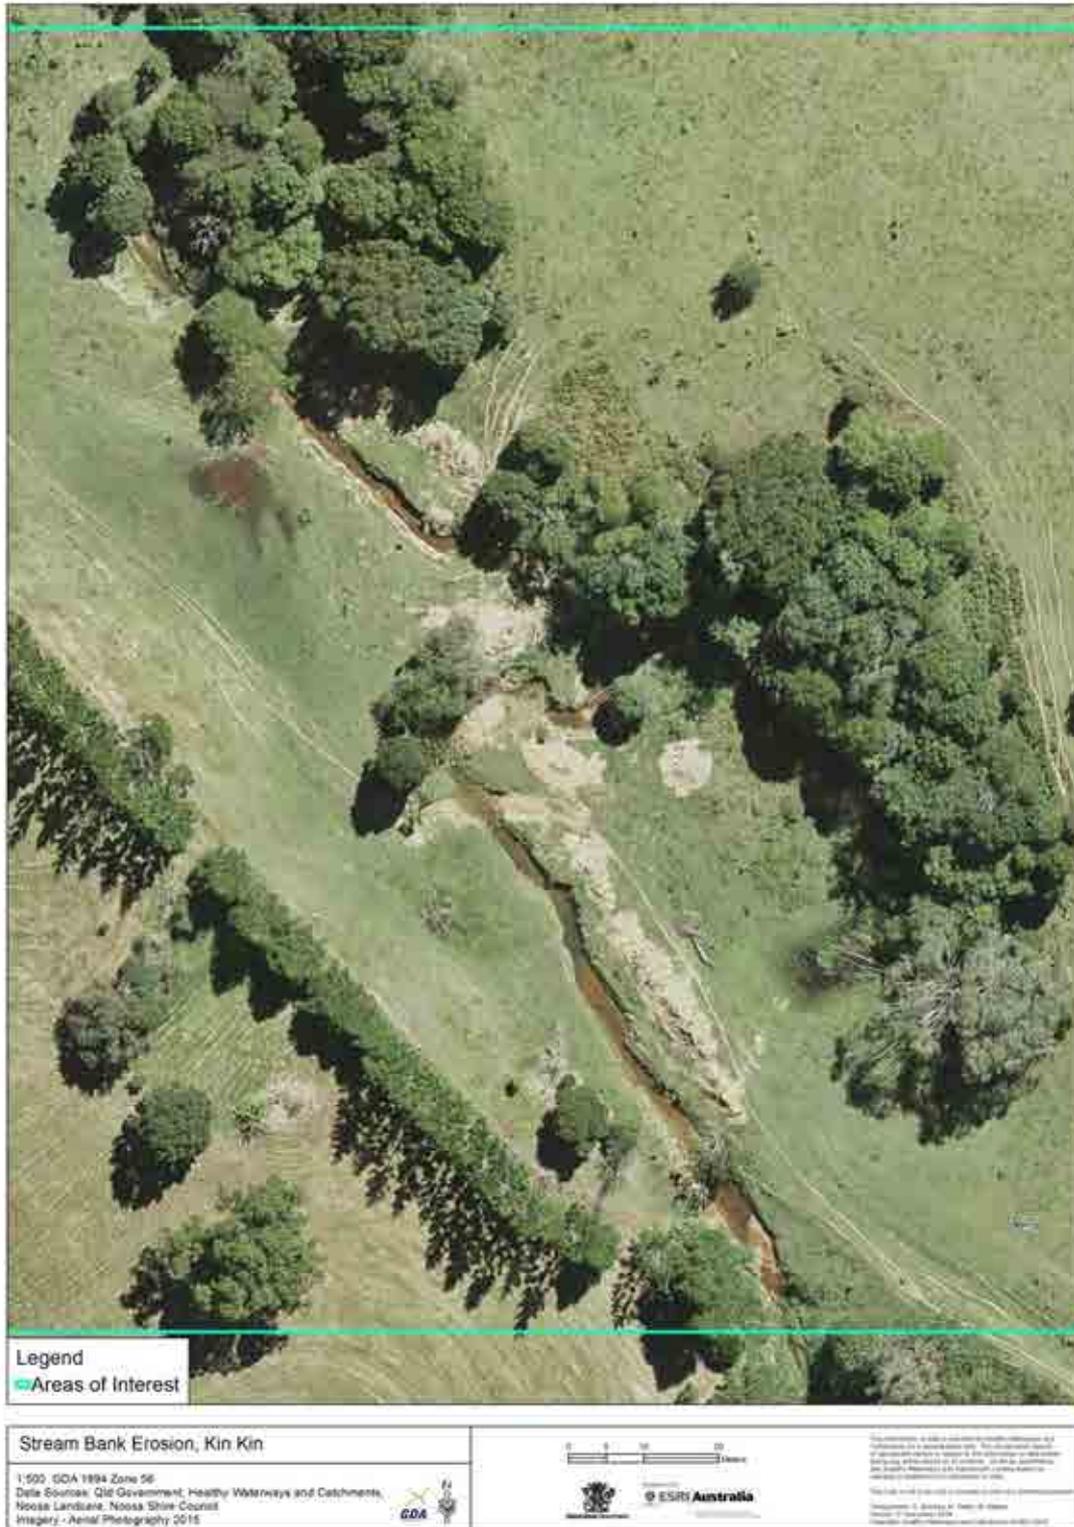
**Map 6a: Aerial photography 2015 showing Erosion Type “stream bank erosion”**

**Stream Bank Erosion:** Stream bank erosion generally happens during floods and rainfall events. The major cause of stream bank erosion is the removal of vegetation on river banks and the removal of sand and gravel from the stream bed.

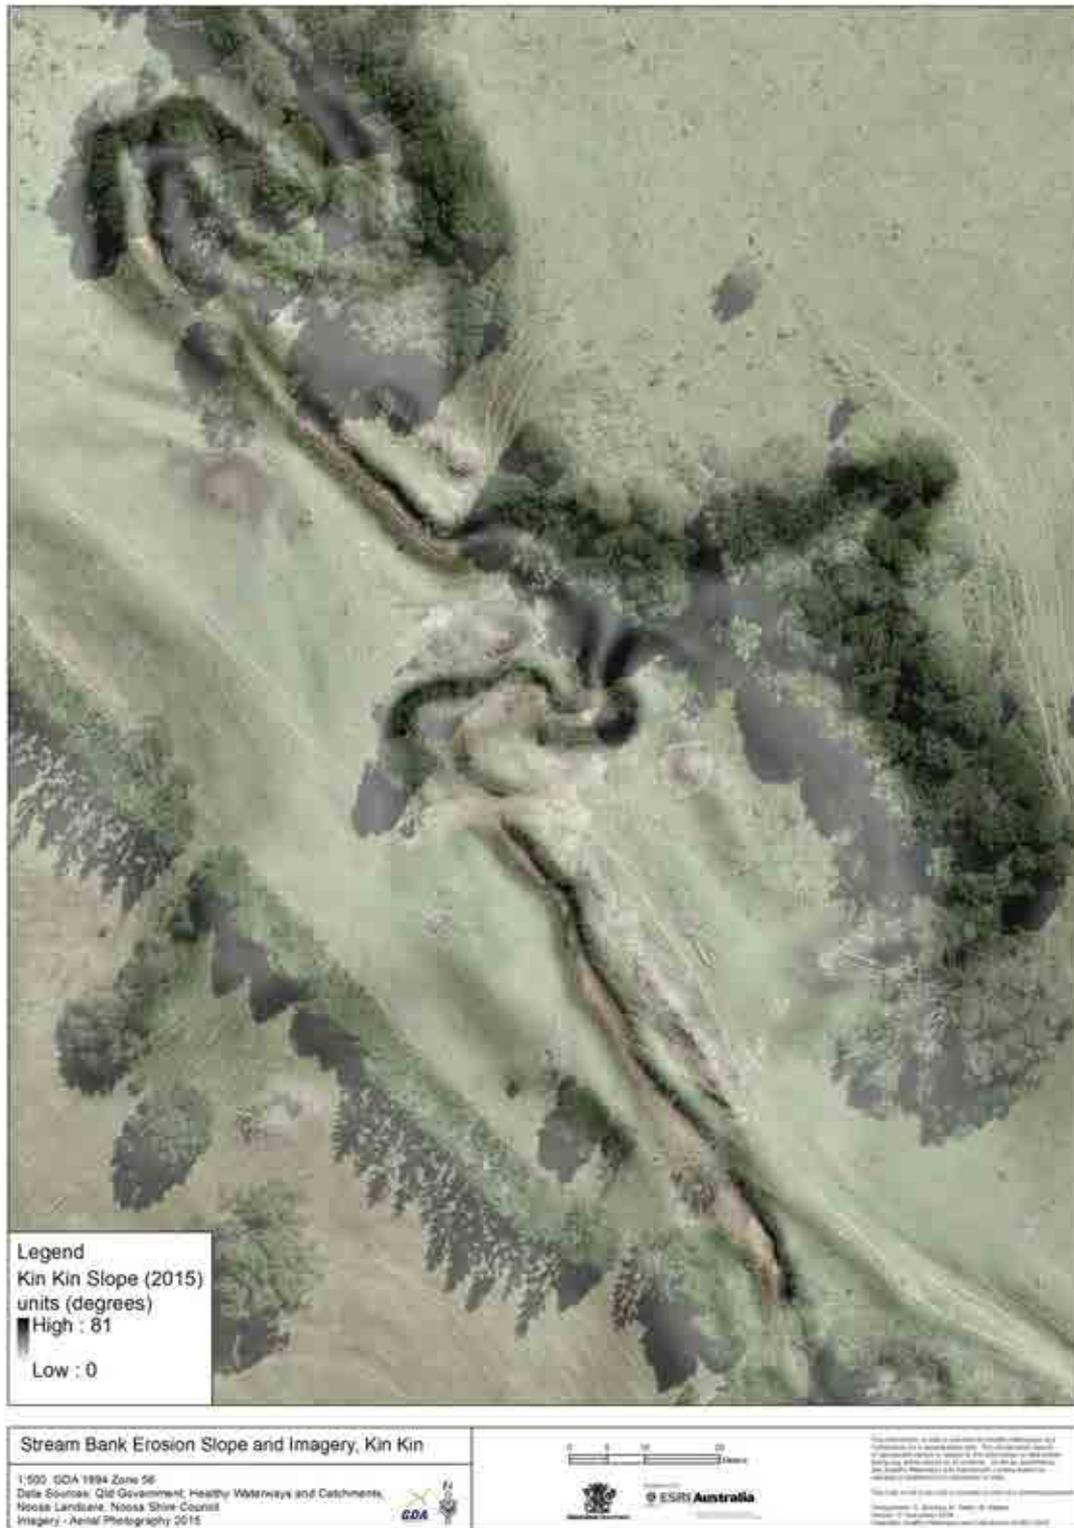
**Map 6b: LiDAR slope showing Erosion Type “stream bank erosion” with steeper creek banks and high slope as dark colour with a steep gully on the eastern side of the waterway**

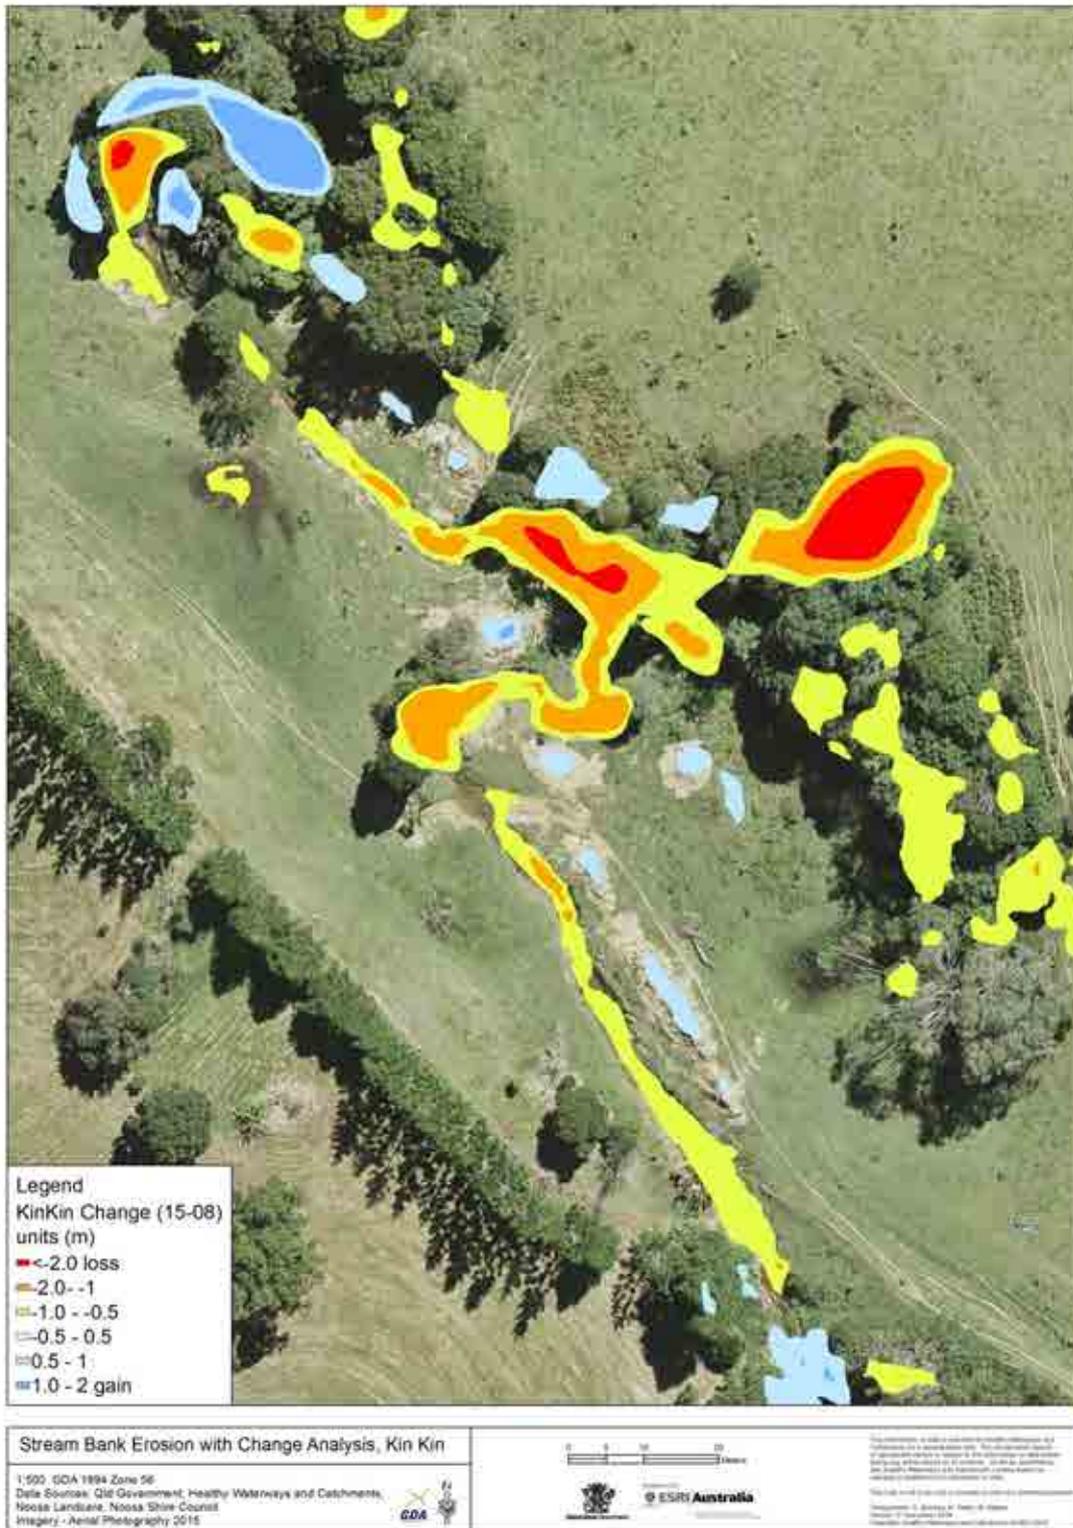
**Map 6c: Change analysis over Erosion Type “stream bank erosion” showing areas of erosion and deposition along the waterway. Steep gully on eastern side also showing signs of erosion.**
