Monitoring of the Noosa River Oyster Reefs; November 2017 - November 2018

Report to Noosa Council, and Queensland Department of Agriculture and Fisheries

December 2018

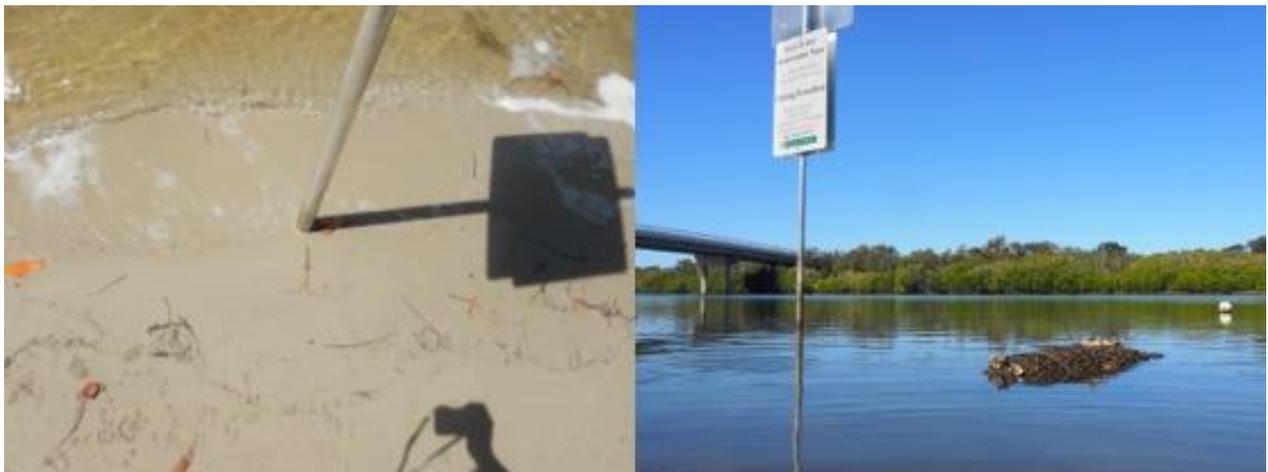
- Poles holding the signs were installed using a narrow water jet ‘spear’. Use of this gear ensured that only a very narrow (< 20 cm diameter in all cases) area of the seabed was disturbed (Figure 4). Sign posts were then driven further into the substrate, to a mean depth of 2.7 m (min 1.8 m, max 3.5 m; Table 1), using a post driver (Figure 4).

Figure 4 The resulting very small footprint of sign posts following installation by the water jet (left) and a completed oyster reef in Weyba Creek (right).

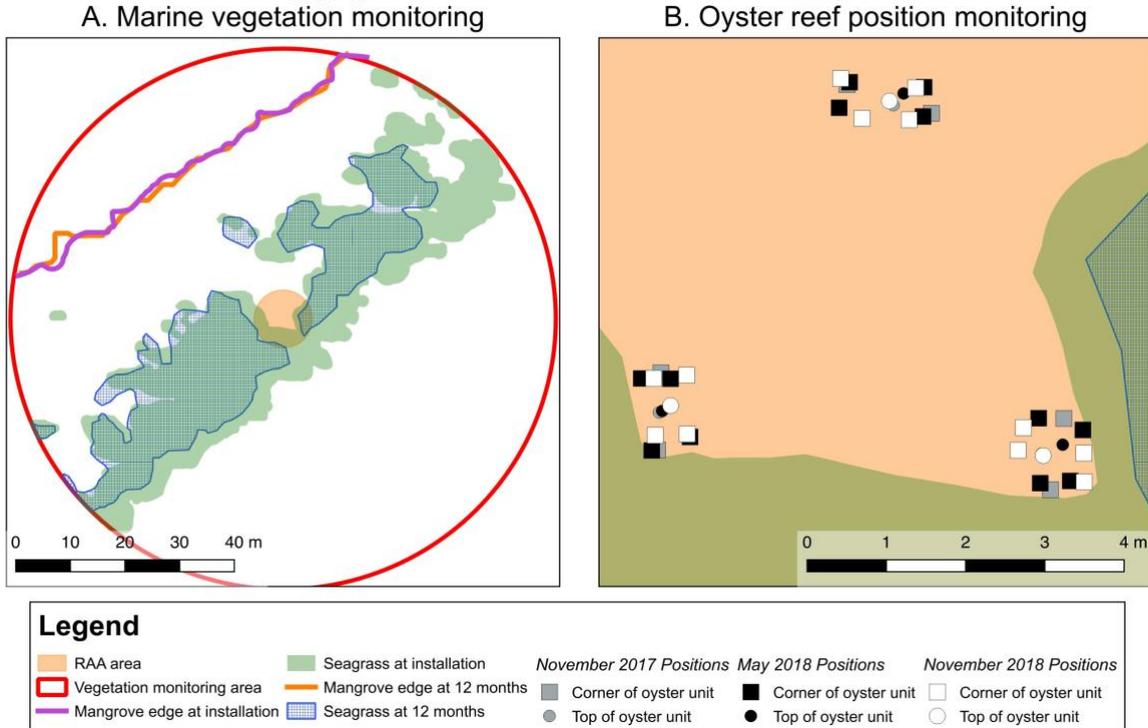
Site 3

Figure 6 Map of (A) aerial extents of seagrass and mangrove edges and (B) oyster reef unit positions (at installation, and at 6 and 12 months post installation) at site 3 in the Noosa River.

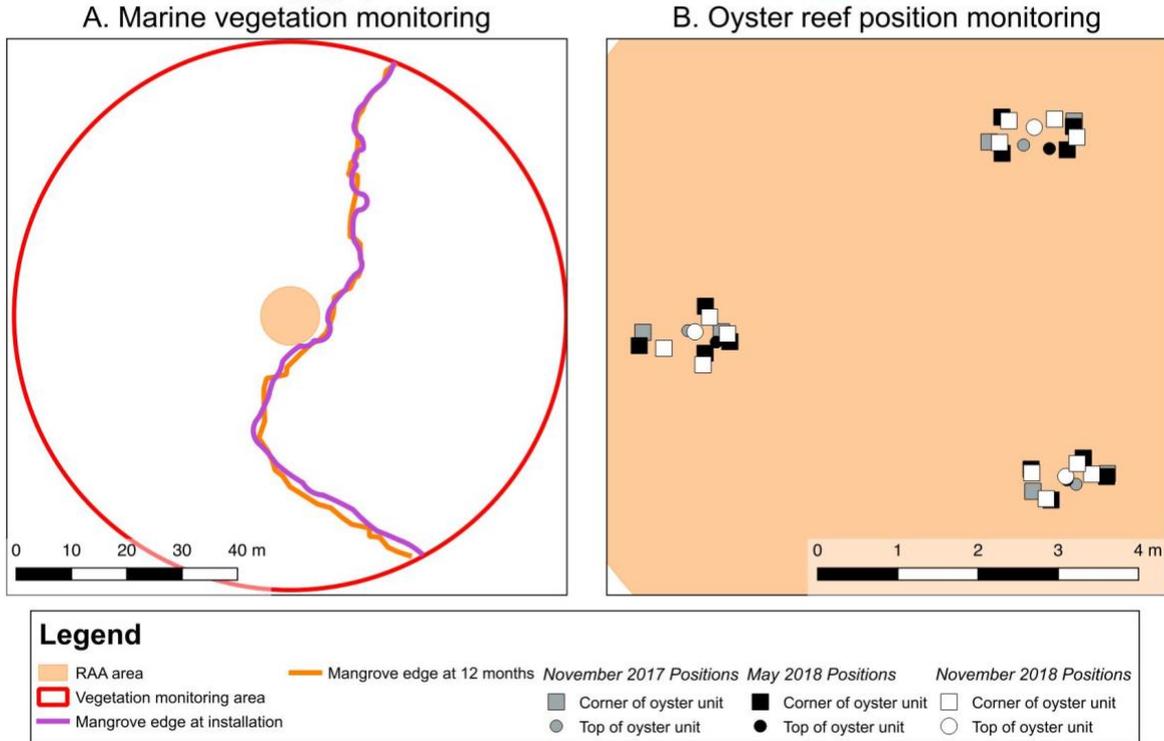
Site 4

Figure 7 Map of (A) mangrove edges and (B) oyster reef unit positions (at installation, and at 6 and 12 months post installation) at site 4 in the Noosa River.

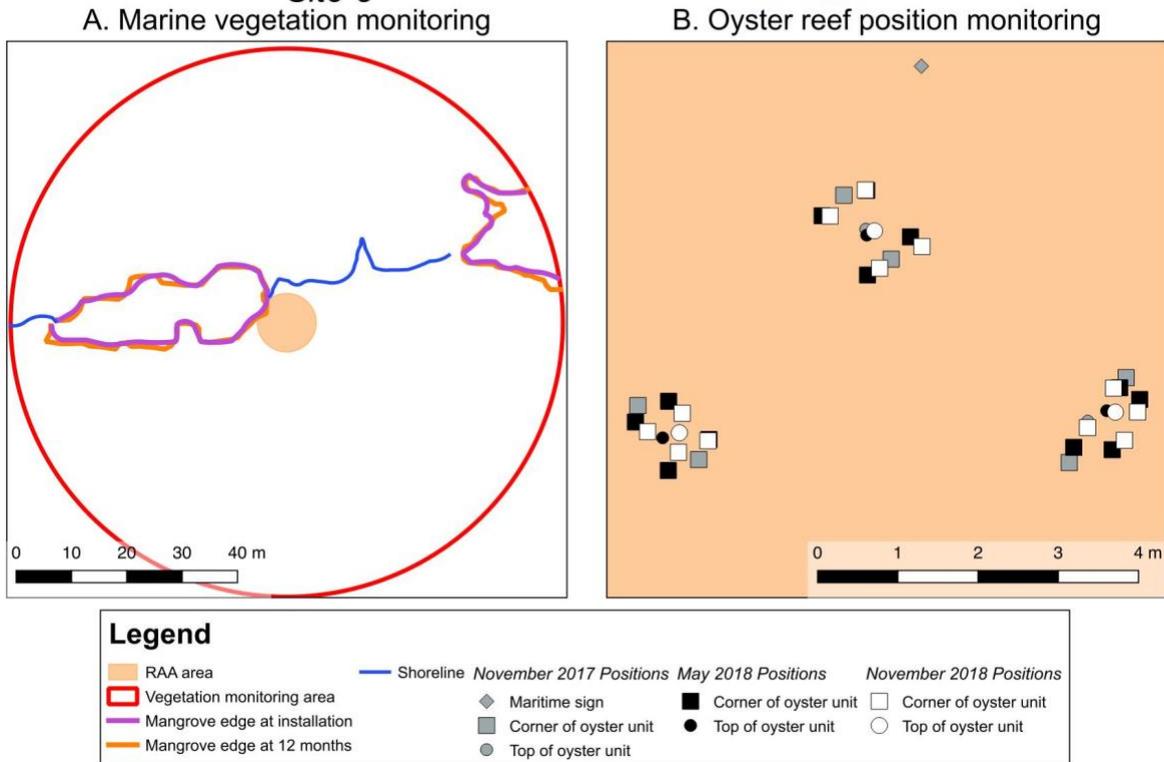
Site 5

Figure 8 Map of (A) aerial extents of seagrass and mangrove edges and (B) oyster reef unit positions (at installation, and at 6 and 12 months post installation) at site 5 in the Noosa River.

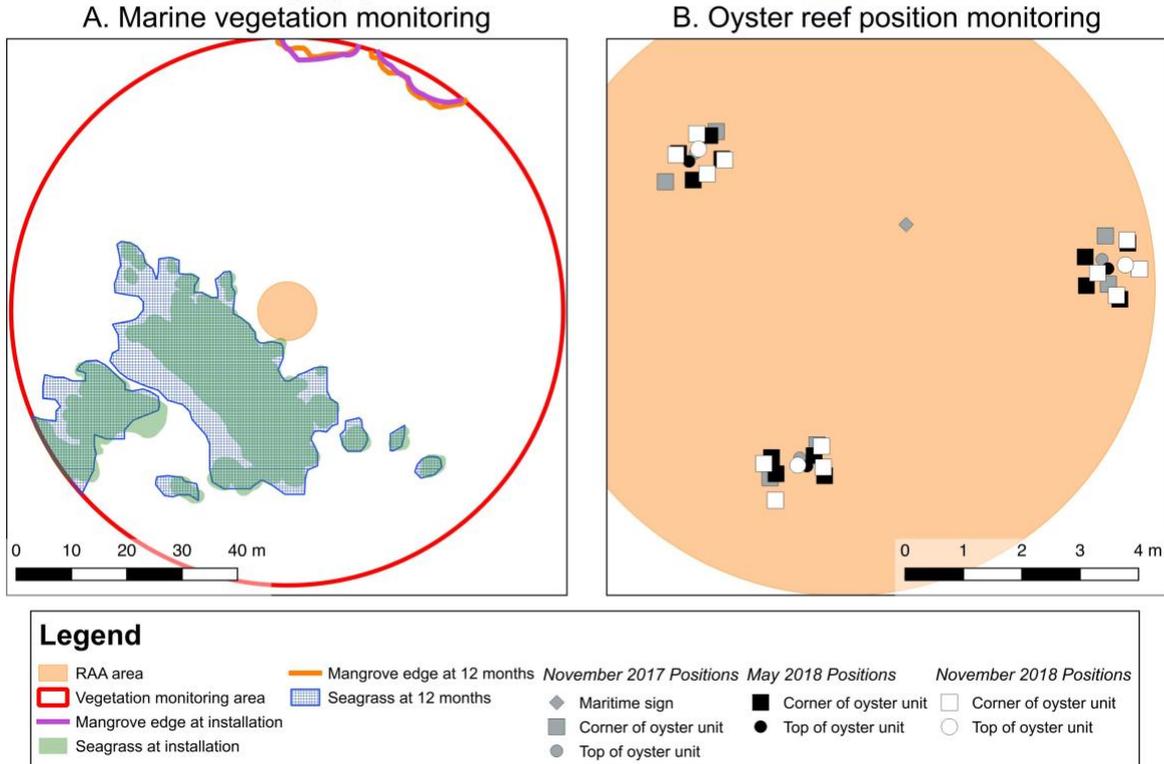
Site 6

Figure 9 Map of (A) aerial extents of seagrass and mangrove edges and (B) oyster reef unit positions (at installation, and at 6 and 12 months post installation) at site 6 in the Noosa River.

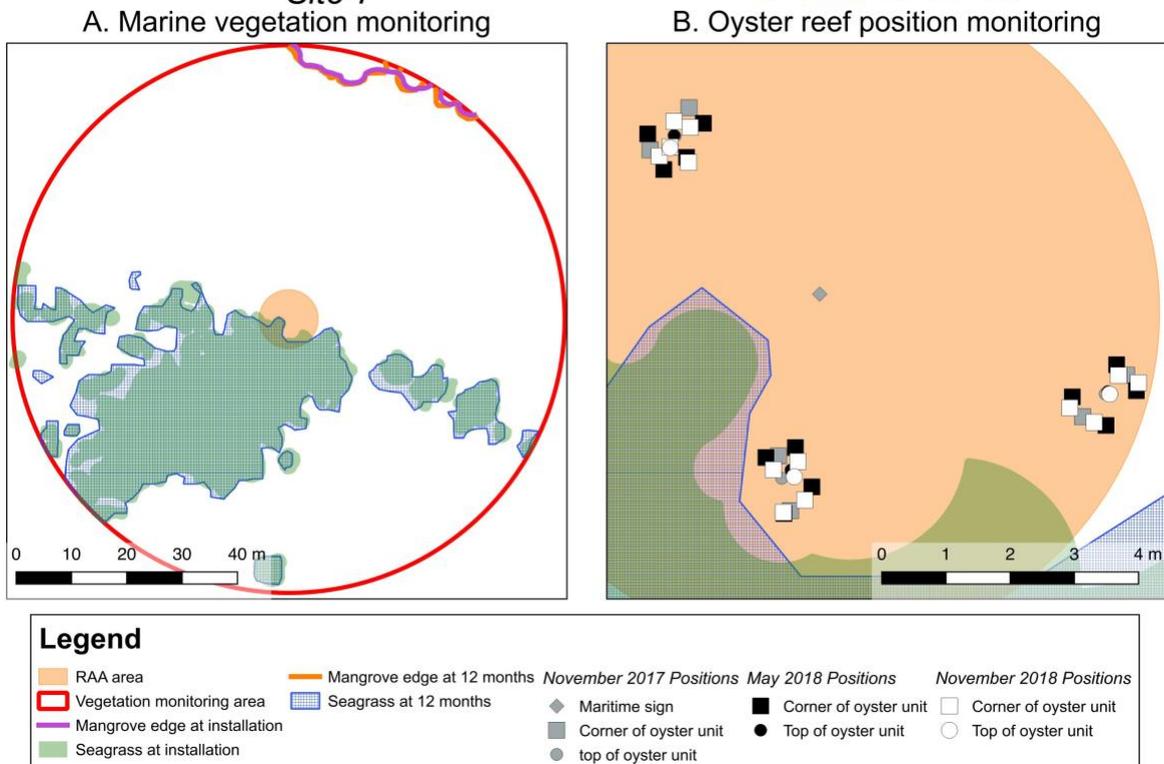
Site 7

Figure 10 Map of (A) aerial extents of seagrass and mangrove edges and (B) oyster reef unit positions (at installation, and at 6 and 12 months post installation) at site 7 in the Noosa River.

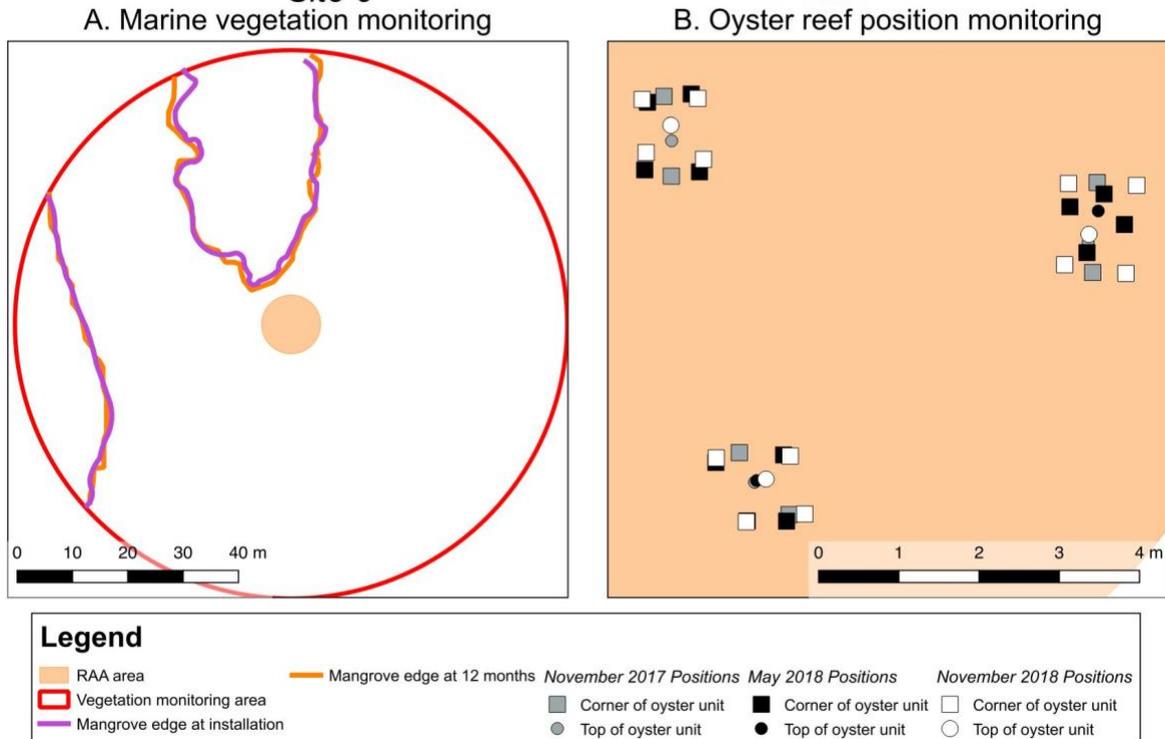
Site 9

Figure 12 Map of (A) mangrove edges and (B) oyster reef unit positions (at installation, and at 6 and 12 months post installation) at site 9 in the Noosa River.

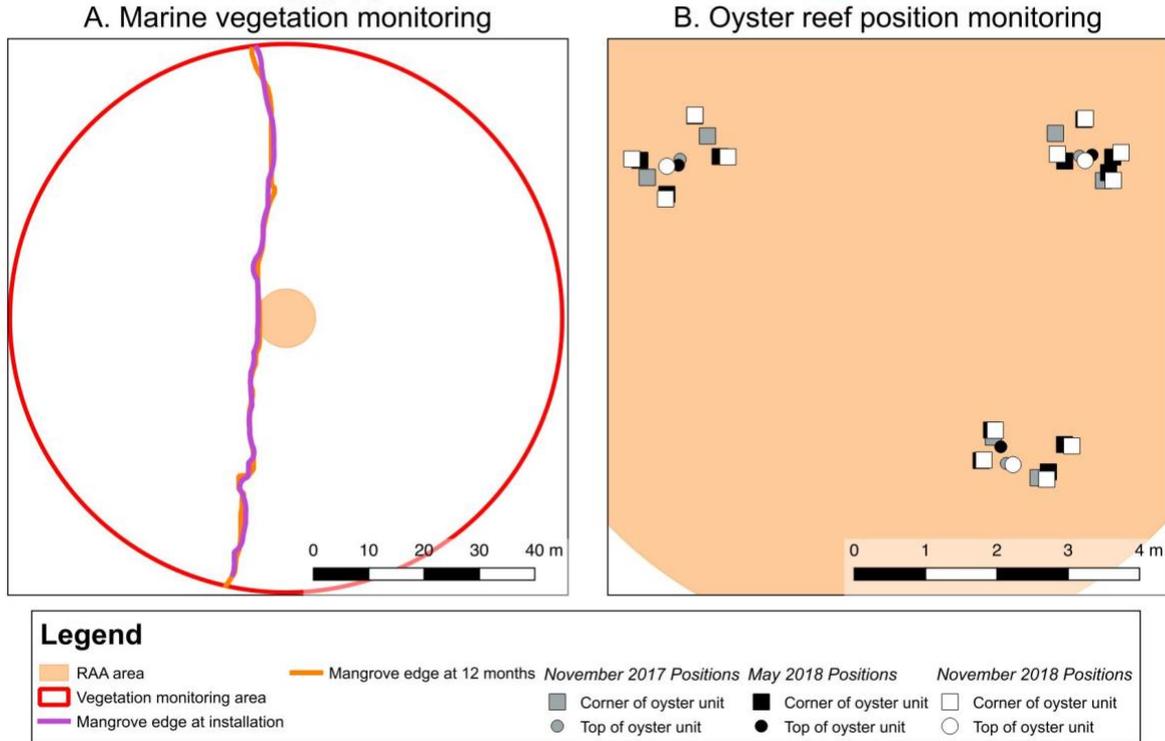
Site 10

Figure 13 Map of (A) mangrove edges and (B) oyster reef unit positions (at installation, and at 6 and 12 months post installation) at site 10 in the Noosa River.

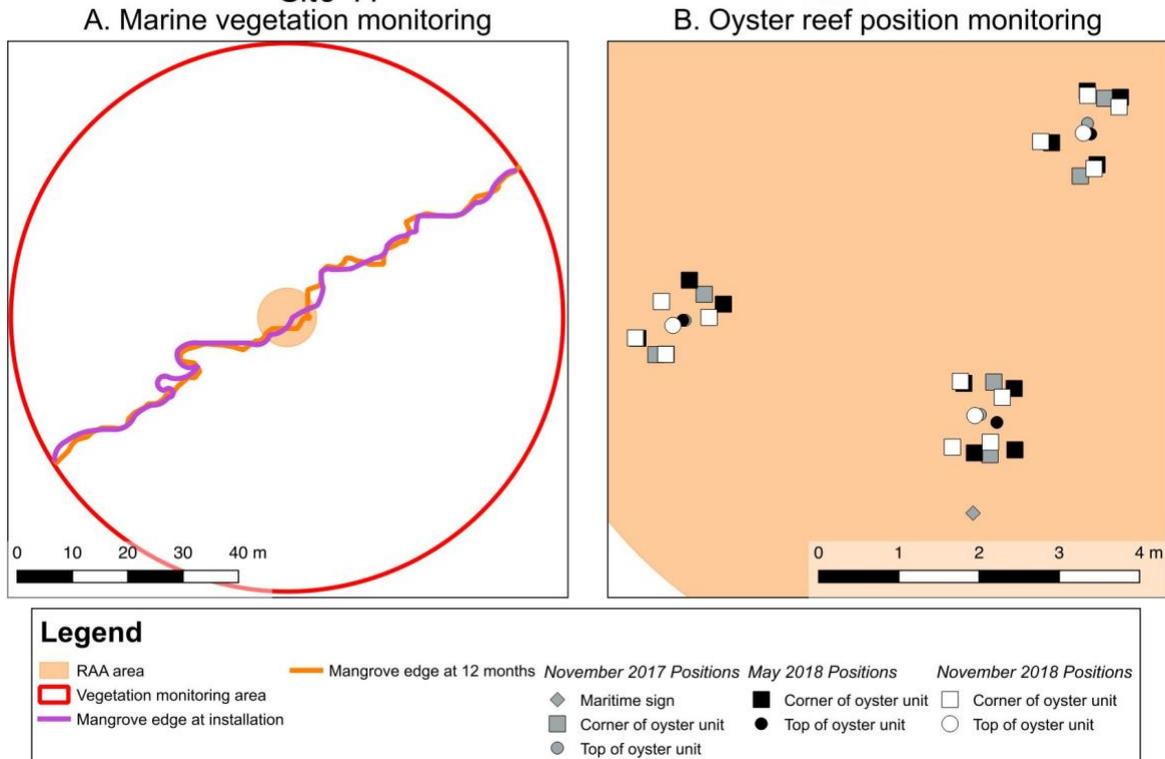
Site 11

Figure 14 Map of (A) mangrove edges and (B) oyster reef unit positions (at installation, and at 6 and 12 months post installation) at site 11 in the Noosa River.

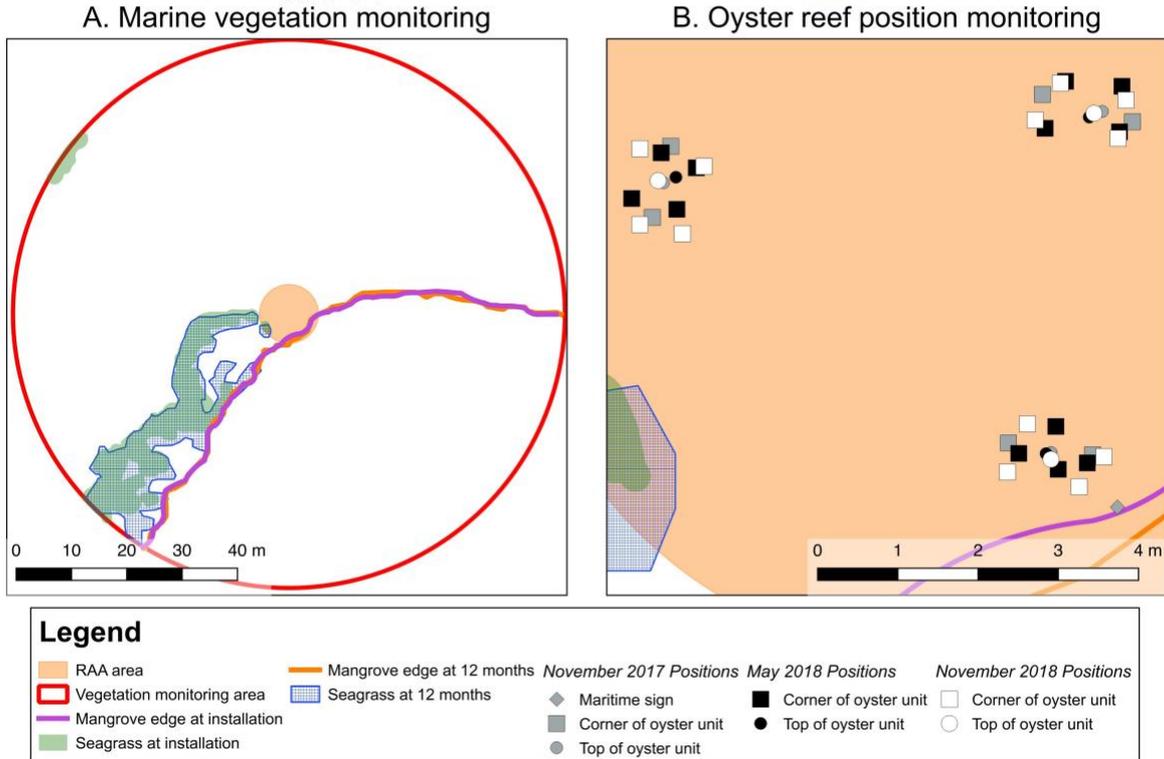
Site 12

Figure 15 Map of (A) aerial extents of seagrass and mangrove edges and (B) oyster reef unit positions (at installation, and at 6 and 12 months post installation) at site 12 in the Noosa River.

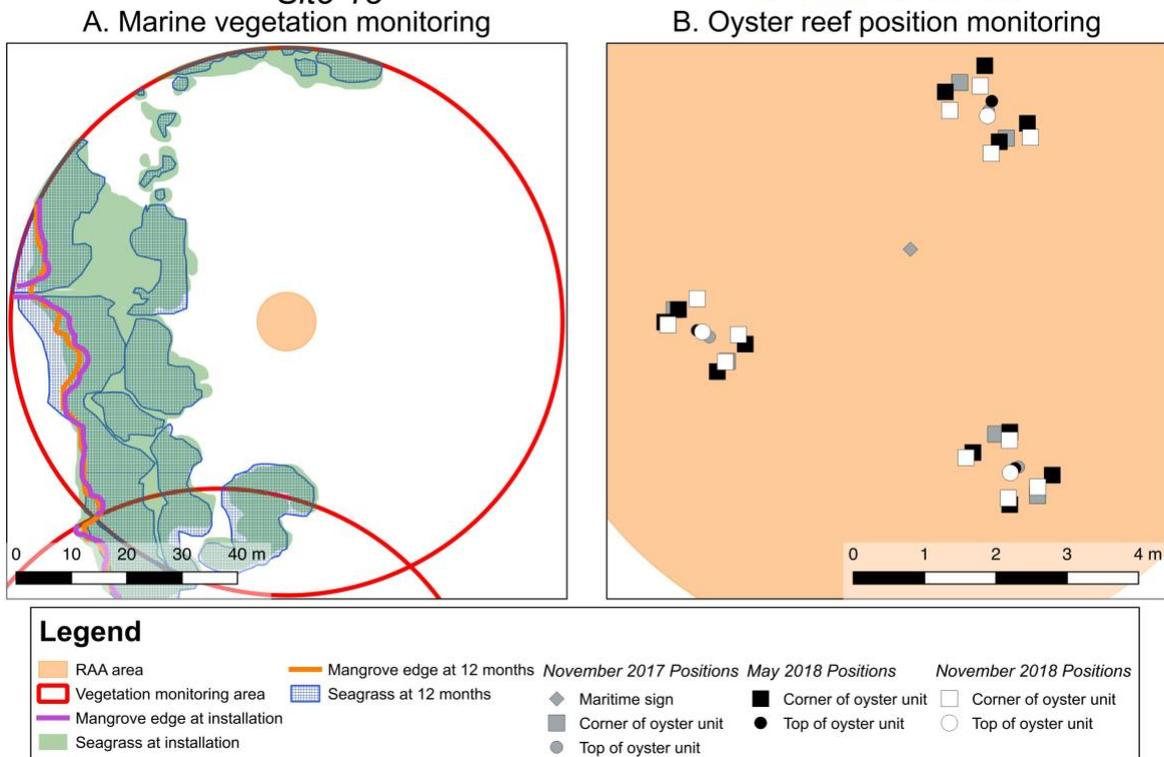
Site 13

Figure 16 Map of (A) aerial extents of seagrass and mangrove edges and (B) oyster reef unit positions (at installation, and at 6 and 12 months post installation) at site 13 in the Noosa River.

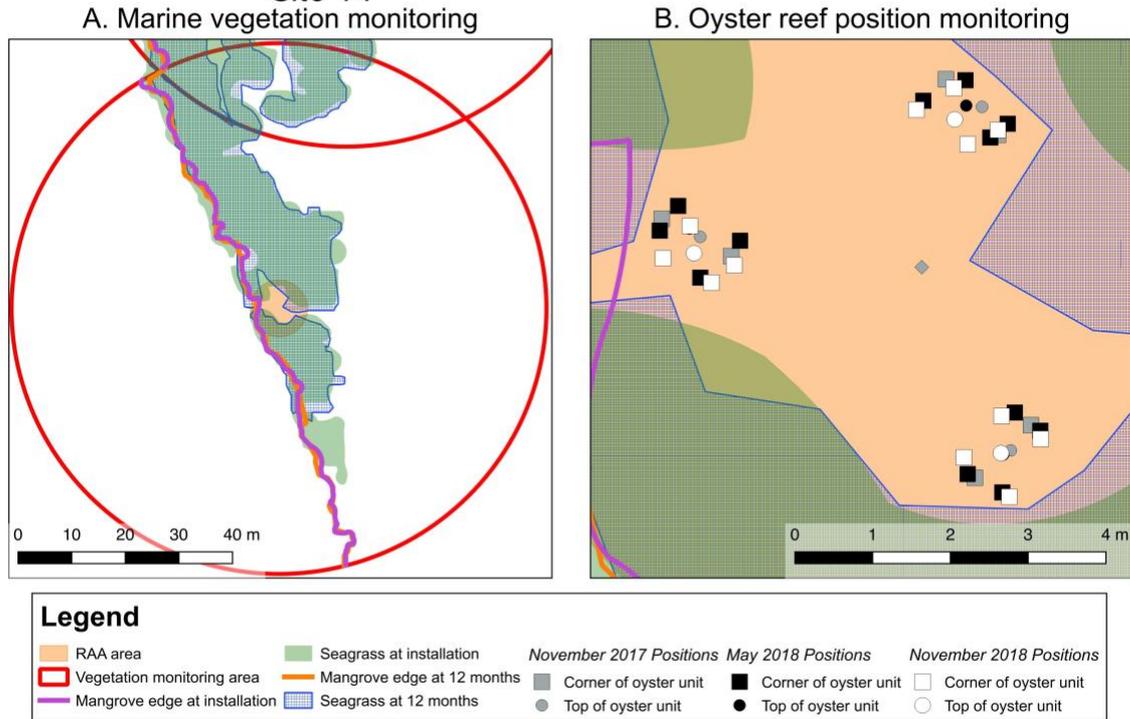
Site 14

Figure 17 Map of (A) aerial extents of seagrass and mangrove edges and (B) oyster reef unit positions (at installation, and at 6 and 12 months post installation) at site 14 in the Noosa River.

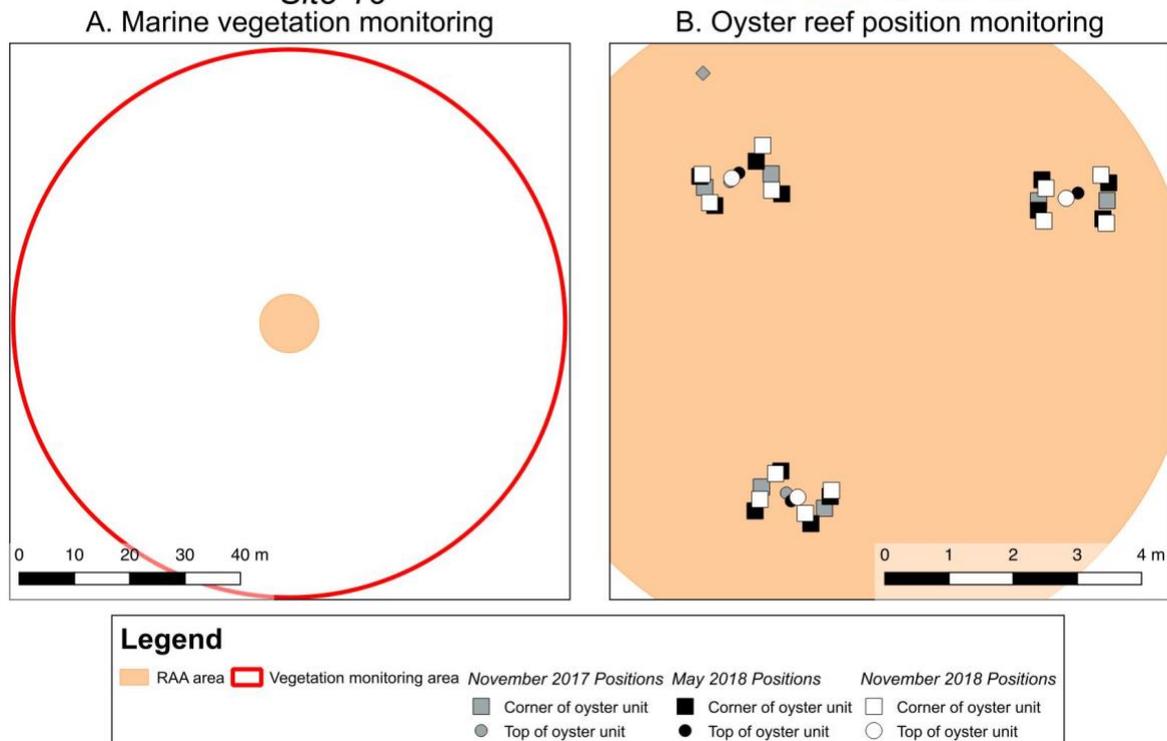
Site 16

Figure 18 Map of (A) vegetation monitoring area (note there was no seagrass or mangroves at this site) and (B) oyster reef unit positions (at installation, and at 6 and 12 months post installation) at site 16 in the Noosa River.

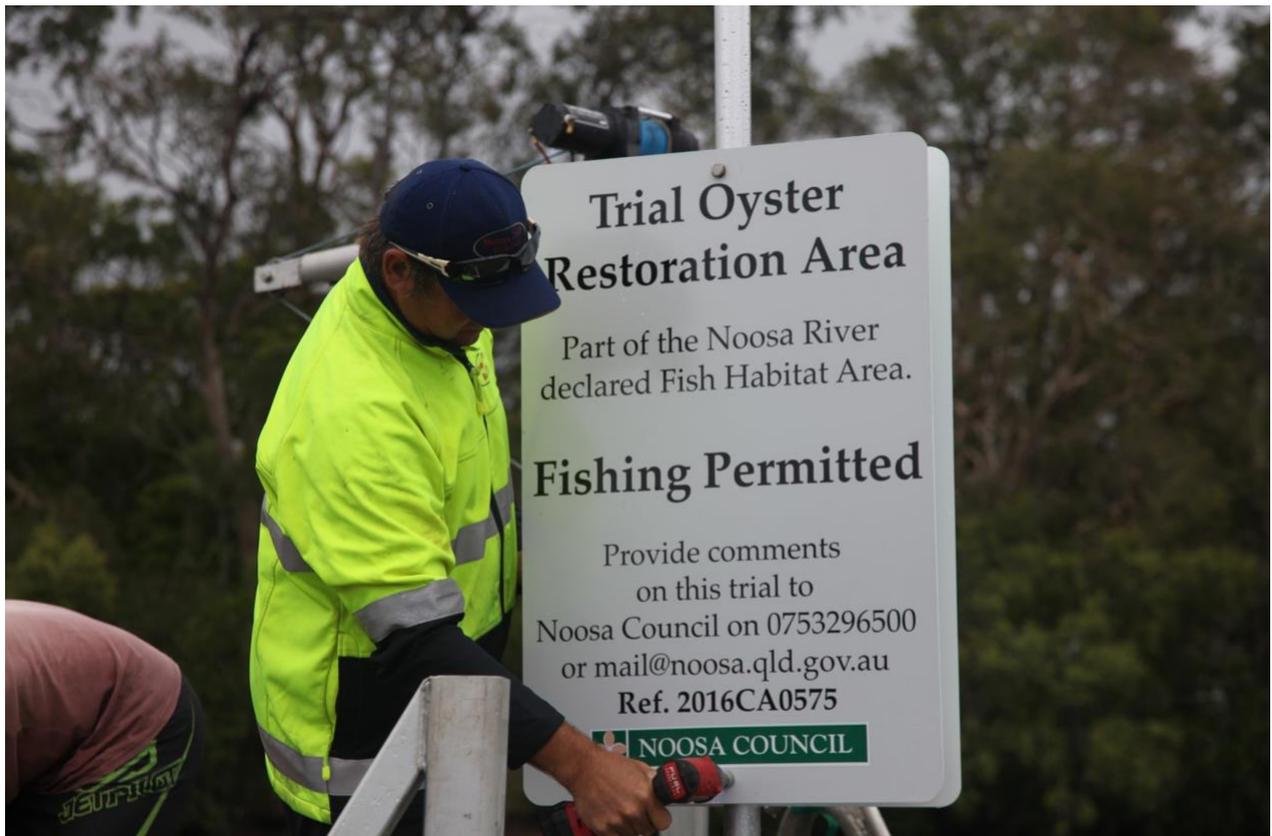
These were immediately replaced by the USC team. Some buoys were, however, removed from sites the night after being reinstalled, thereby indicating very regular removal of reef hardware by members of the public at some sites. This lack of buoys on the corner of the oyster reefs is likely a contributor to some of the reefs being hit by boat propellers etc. Regular monitoring of these buoys is required to ensure that they stay in place. No site signage was damaged or modified during the past year, so no maintenance or replacement has been necessary (Figure 22).

Figure 22 Oyster reef restoration signage being installed at an oyster reef restoration site in the Noosa River, with text on the sign indicating the contact details at Noosa Council for comments on the broader oyster restoration project.
