Our Reference: 1533L2020.1

**RE: Noosa Oyster Reef Restoration – 2<sup>nd</sup> Annual Monitoring Report 2019**

Please find attached the second annual assessment of the success of the Noosa oyster reef restoration trial, which includes assessments completed at the end of the second spat settlement season in May 2019 and start of the third spat settlement season in October 2019.

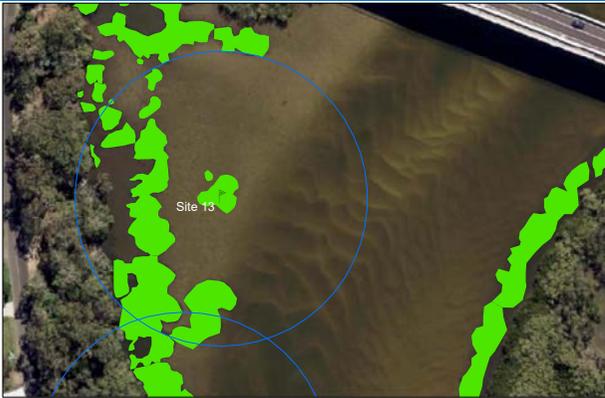
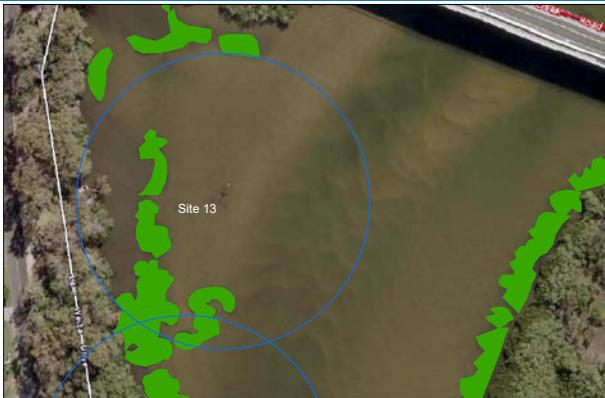
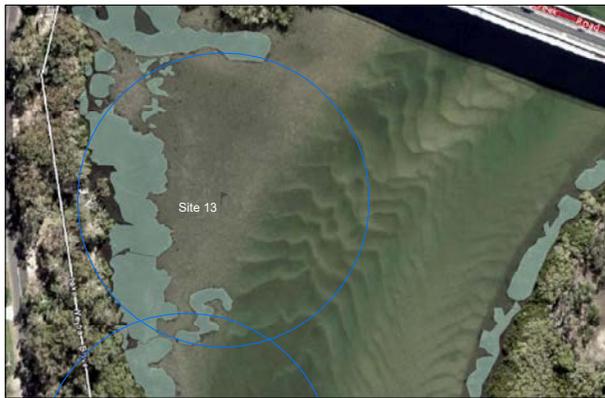
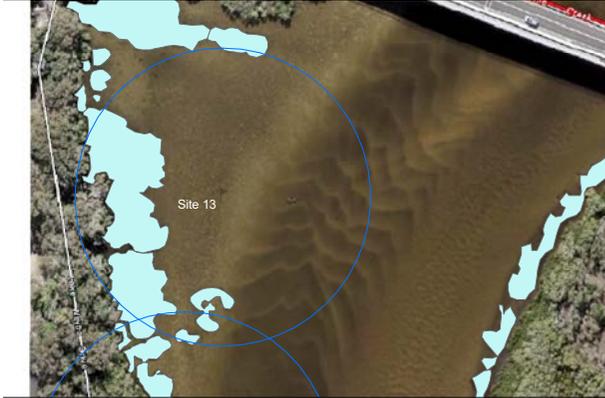
**Noosa Estuary seagrass 2019**  
Site: 13

Restoration units have largely been consolidated by foliose macroalgae (Figure 4). The restoration units at this site are surrounded by established seagrass beds (dense, long bladed *Zostera mulleri*), which have increased in extent since deployment, particularly closing gaps over bare sediment around the restoration units (Figure 4, Figure 5 & refer to Table 4). Numerous juvenile fish were observed using the reef restoration units and moving between them and the surrounding seagrass in both April and October 2019 (Figure 7).
