Noosa Estuary Trial Oyster Reef Restoration

Final Monitoring Report

Prepared for: Noosa Council

**Prepared by Ecological Service Professionals Pty Ltd on behalf of Noosa Biosphere
Reserve Foundation**

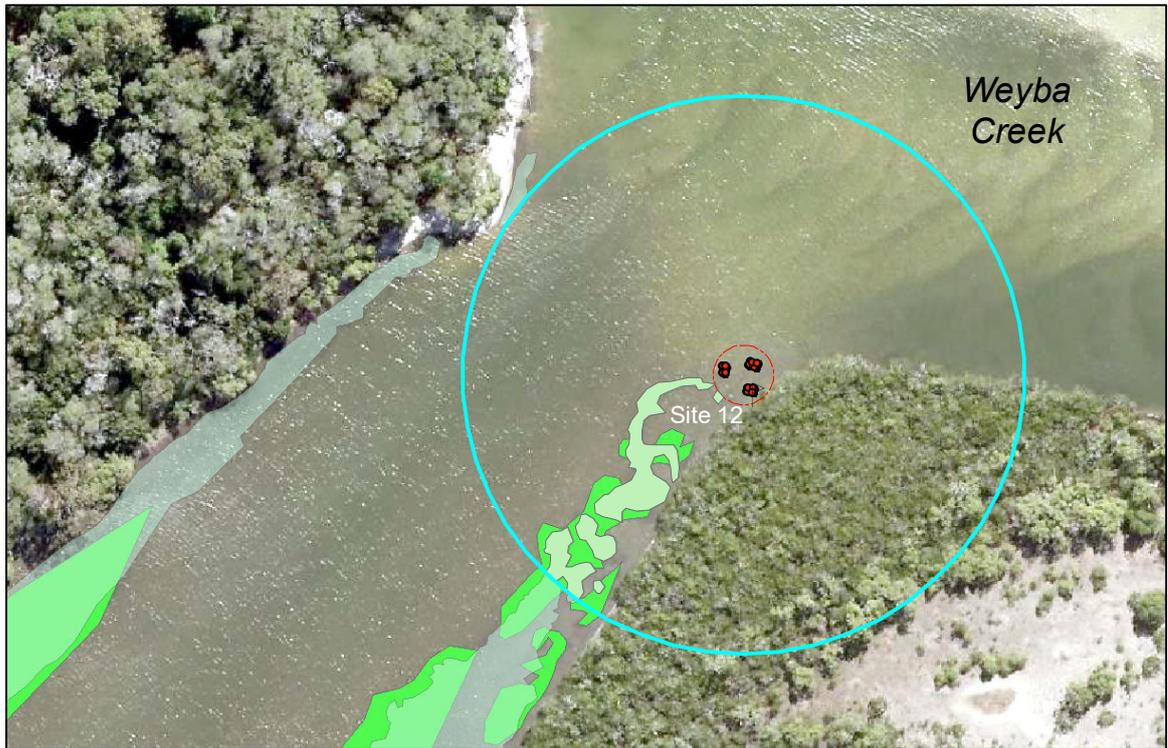
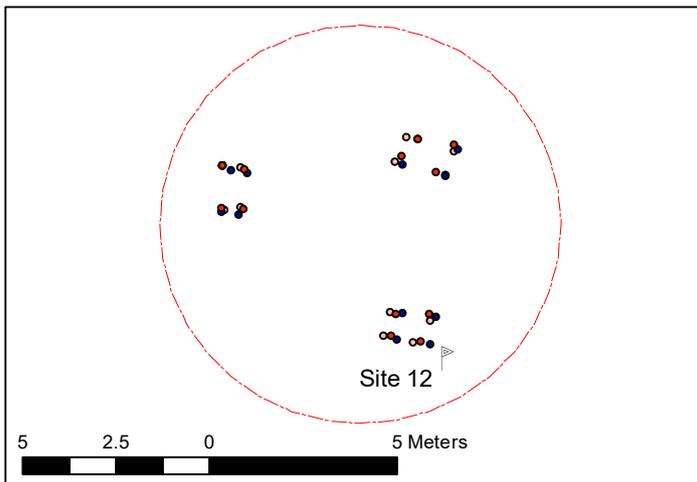
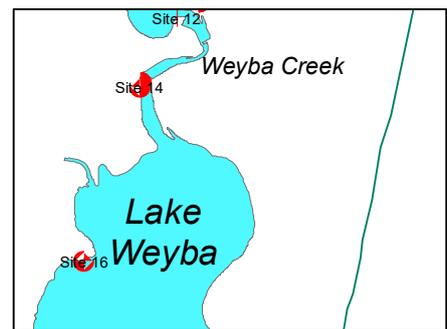
Figure 6 Location of restoration structures at Site 12 in relation to the RAA boundary and seagrass mapped in the area in November 2020

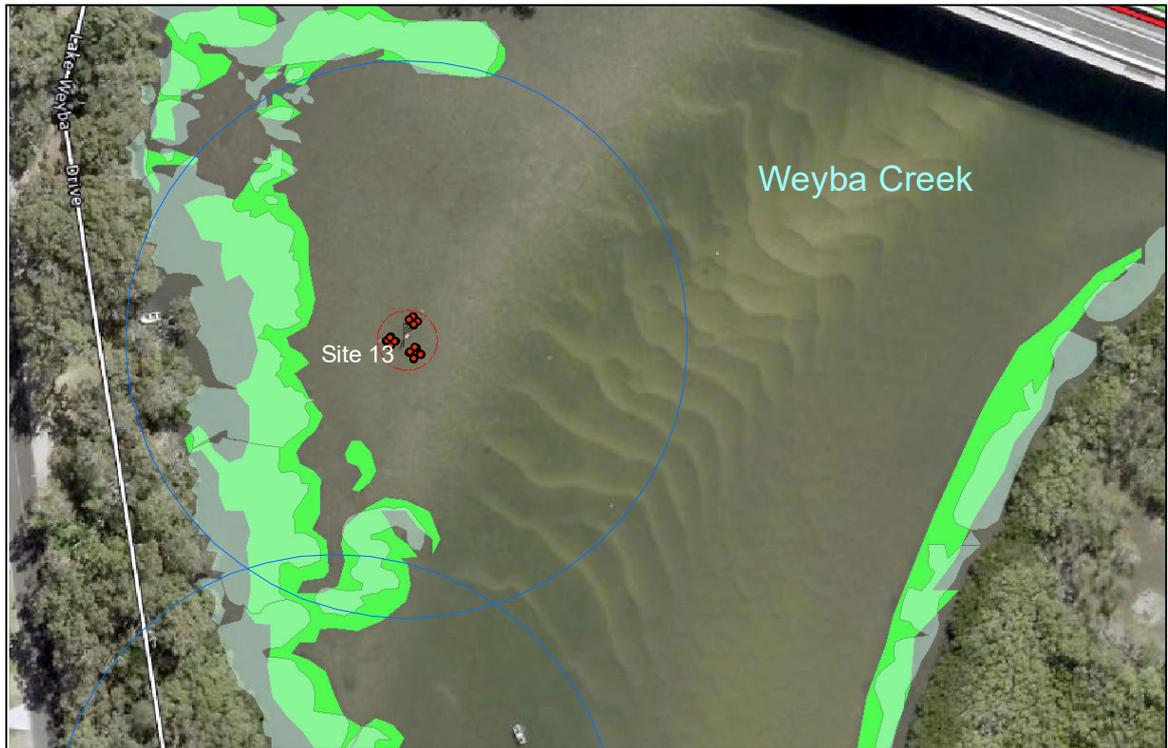
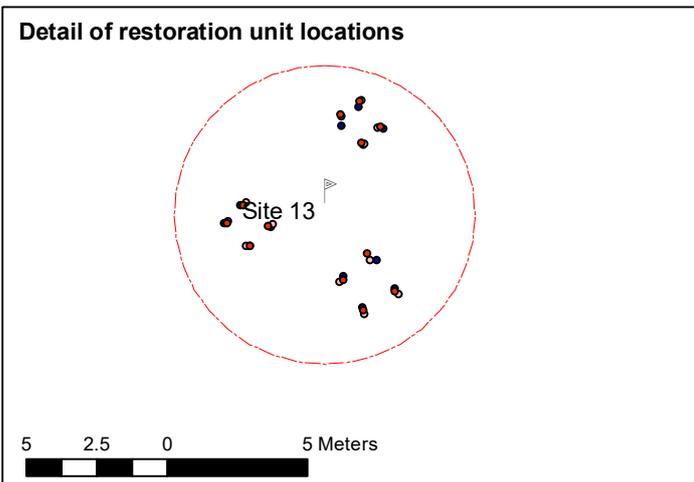
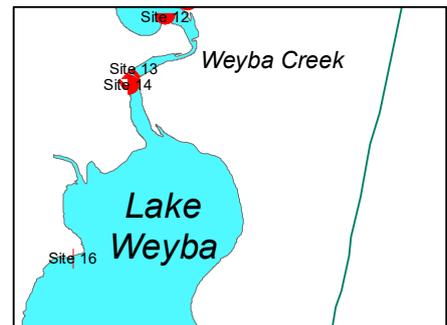
OUTCOME: Restoration units have been removed from Site 13 and the area rehabilitated – refer to photos pre- and post-removal provided in Appendix A.

Figure 9 Location of restoration structures at Site 13 in relation to the RAA boundary and seagrass mapped in the area in November 2020

As the reefs had been almost completely buried in September 2020, the shell patches were removed by hand and the area remediated back to the pre-deployment condition (Figure 22). Subsequent visual assessment of the area after reef removal has demonstrated no ongoing influence of the reefs or removal of the restoration units or signage (Refer to Section 4).

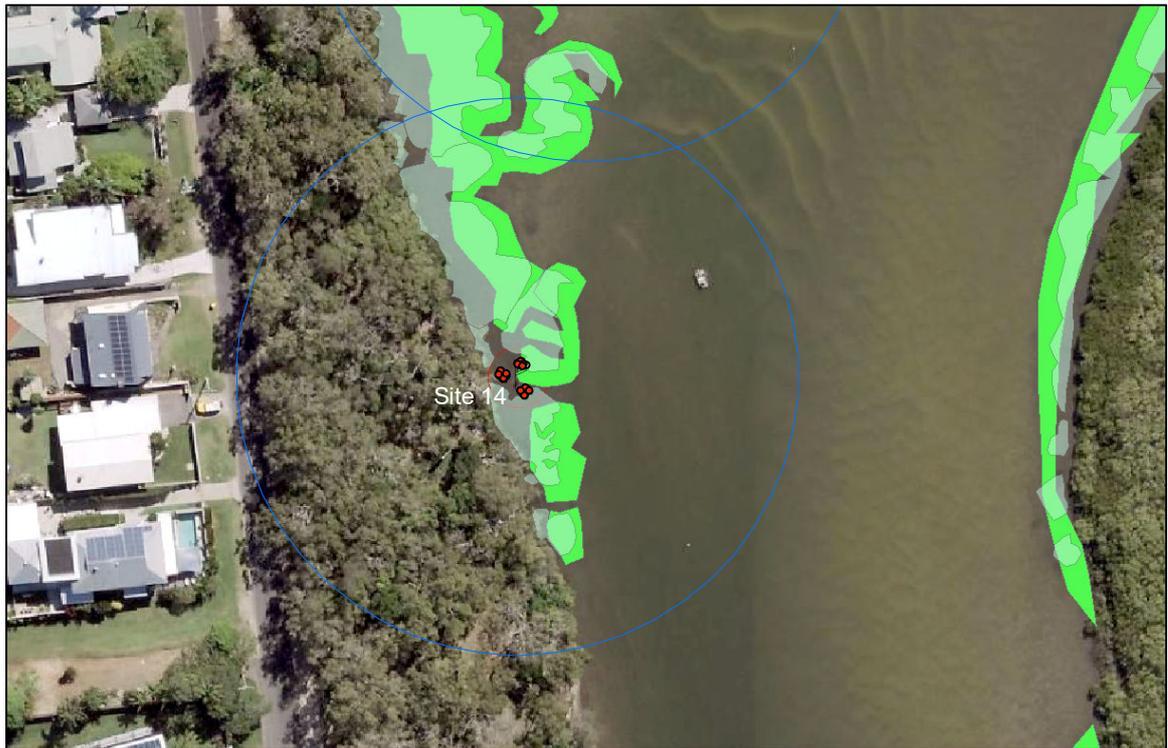
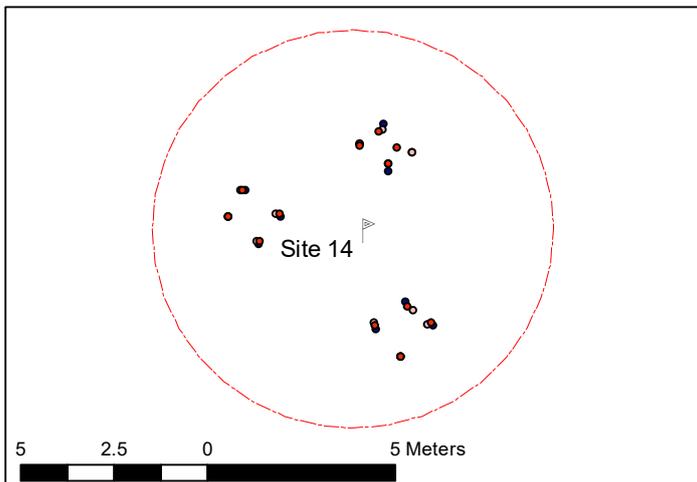
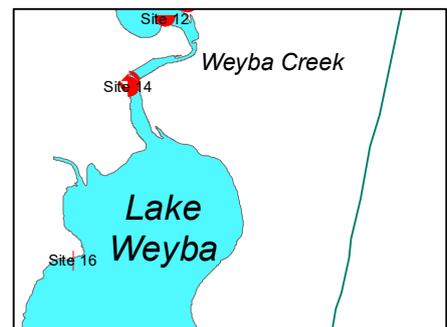
Figure 11 Location of restoration structures at Site 14 in relation to the RAA boundary and seagrass mapped in the area in October and November 2020

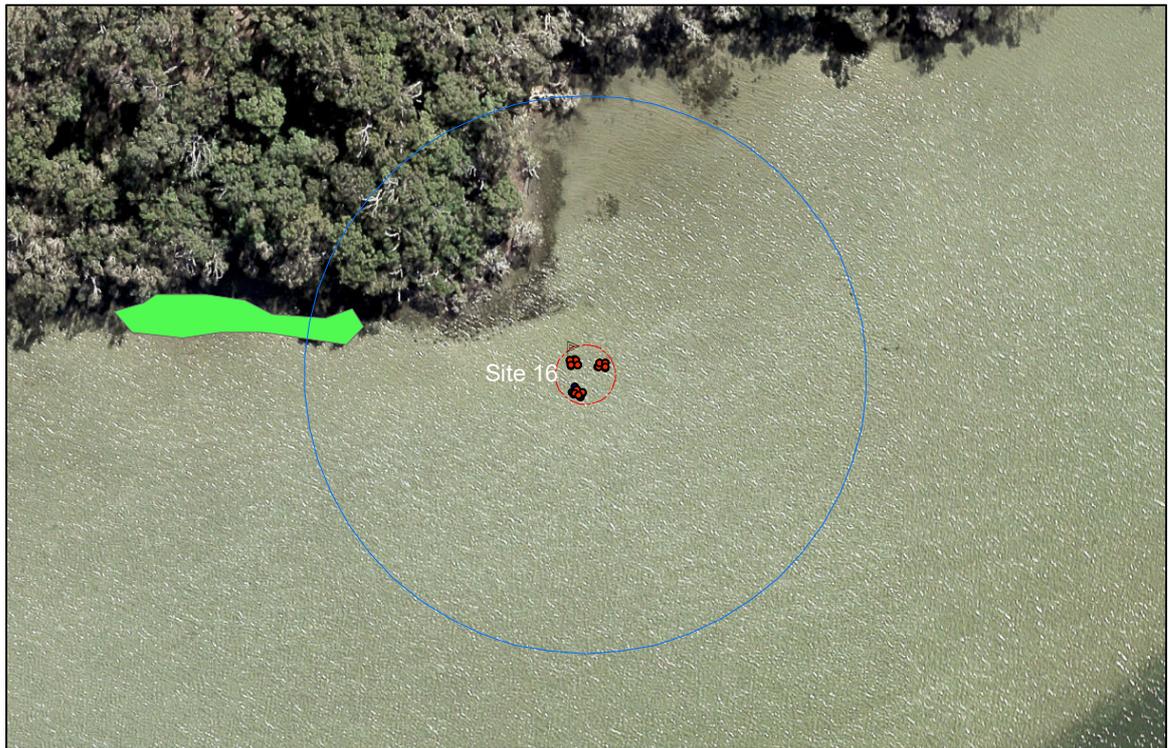
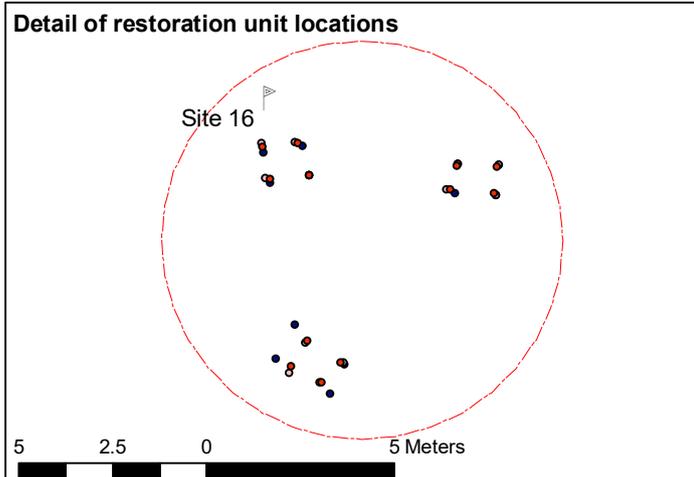
In September 2020, the reef units at Site 16 had not moved substantially from their original position (<0.5m), although due to breakdown of coir mesh observed in October 2019, the oysters contained in the bags had spread to the northwest due to wind driven wave action and become buried under the fine sand. There was a high cover of macroalgae observed on bags at this site in October 2019 and again in September 2020 (Figure 12); although, following burial by sand in September 2020, the shell and much of the macroalgae was largely absent and just covered the surface in some sections.

Figure 13 Location of restoration structures at Site 16 in relation to the RAA boundary and seagrass mapped in the area in November 2020

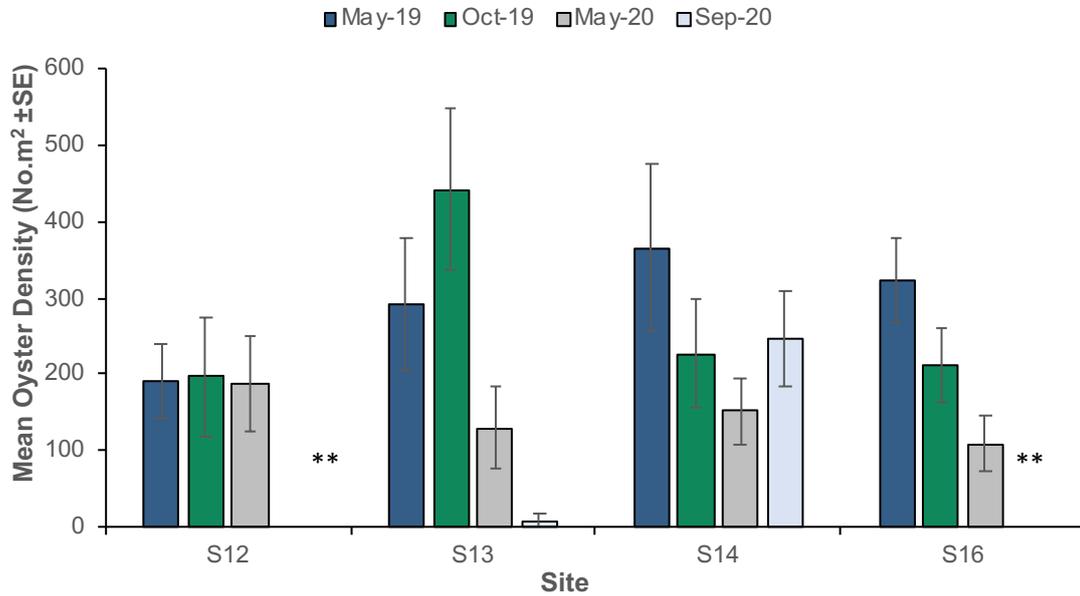
In May 2020, the mean oyster density was relatively consistent amongst the sites, ranging from 109 to 187 oysters.m⁻² (Figure 15). Settlement was a lot lower in 2020 at Sites 13, 14 and 16 than in October 2019, which was a particularly good year for settlement, particularly at Site 13.

The survival of oysters that settled in the 2019–2020 settlement period, as measured in September 2020, was moderate at Site 14 with a similar average density of oysters found between the two monitoring periods although an increase in recently settled spat had reduced the average oyster height. Survival was poor at Site 13, with an 93% reduction in the density of oysters between May and September 2020. The reduction in oyster density and absence of recent settlement recorded at sites 12 and 16 in September 2020, was due to the almost complete burial of shell below the sediment surface, resulting in death of existing oysters and a lack of suitable substrate for spat to settle (Figure 15).

Figure 15 Average (± SE) density of oysters/m² among sites in May 2019, October 2019, May 2020 and September 2020

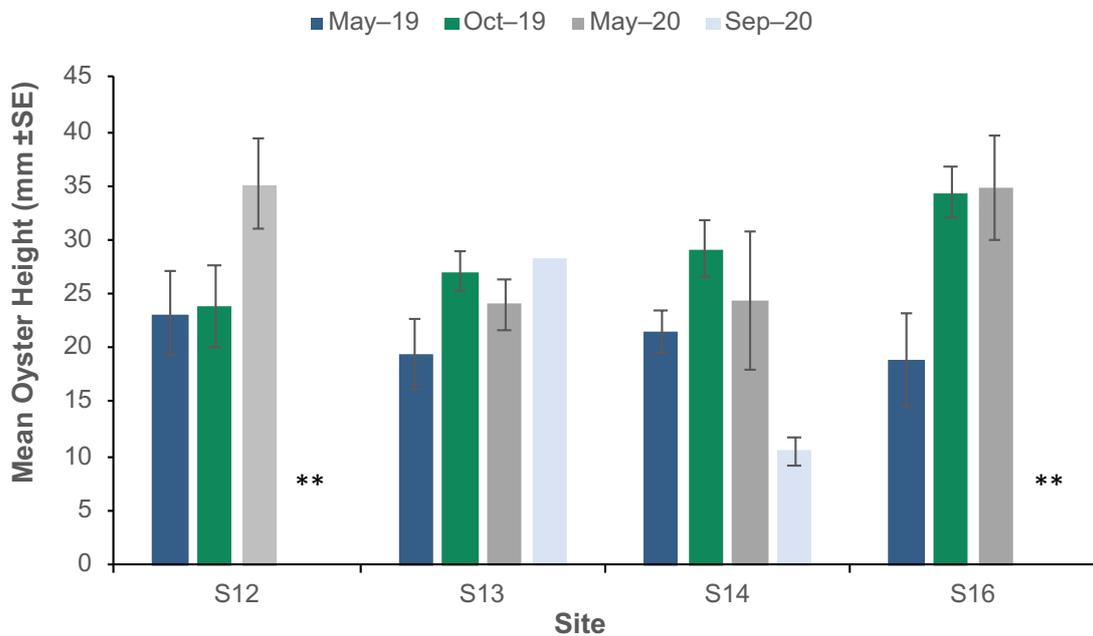
The average height of oysters from May 2019 to September 2020 was relatively consistent among the sites ranging from 11 to 35 mm and tended to increase in average size over time allowing for both growth and new spat recruits (Figure 16). The largest oyster (shell height of

88.5 mm), was recorded at Site 12 in October 2019, with several oysters exceeding 60mm recorded in the subsequent monitoring period in May 2020. In September 2020, there was no successful recruitment oysters of at Site 12 and Site 16 due to burial of the oyster shell at those sites and the maximum size recorded at the other sites was only 29 mm.

Figure 16 Average (± SE) height (cm) of oyster recruits among sites in May 2019, October 2019, May 2020 and September 2020

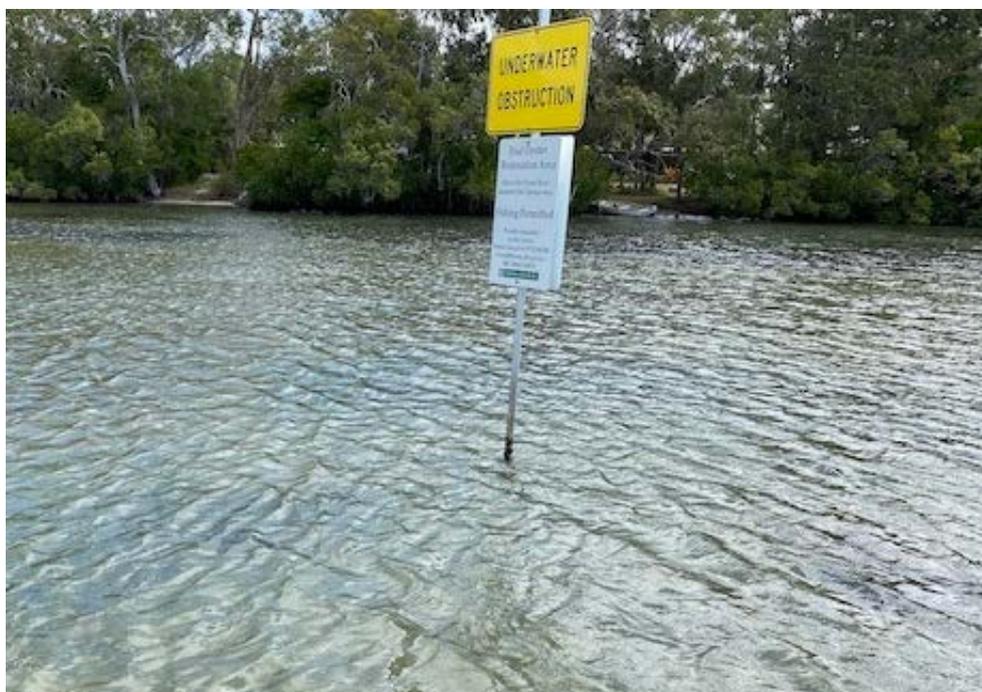
Figure 19 Signage at Site 13 to mark location of the reef and inform public – note that this sign has now been removed

While many of the reef areas in the main river channel had good to very good recruitment of oysters, a key learning from the trial is to provide additional communication and education to river users to reduce potential accidental damage. This could be achieved through dedicated signage at boat ramps and accessible information handouts for tourists hiring vessels who may have limited boating experience and be unfamiliar with the objective of the study.

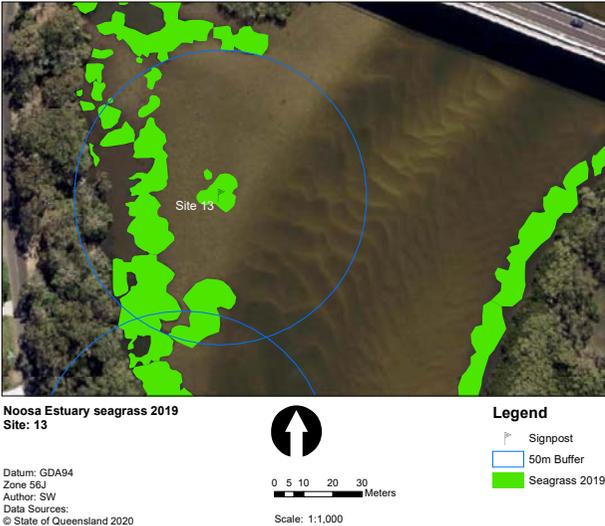
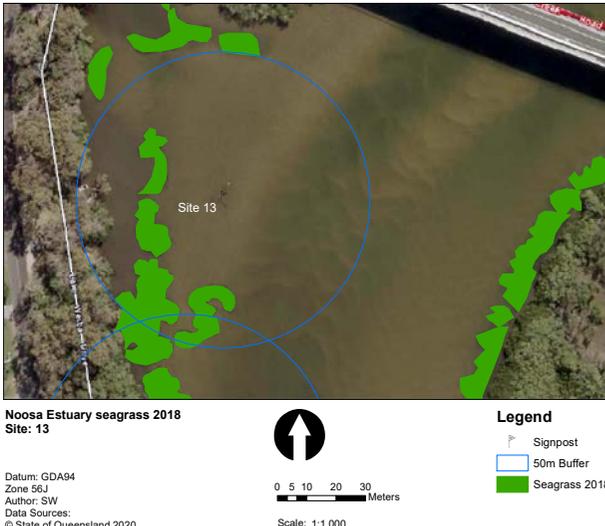
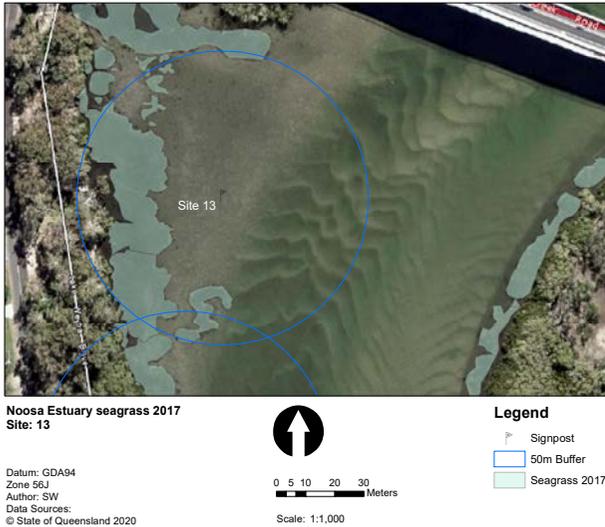
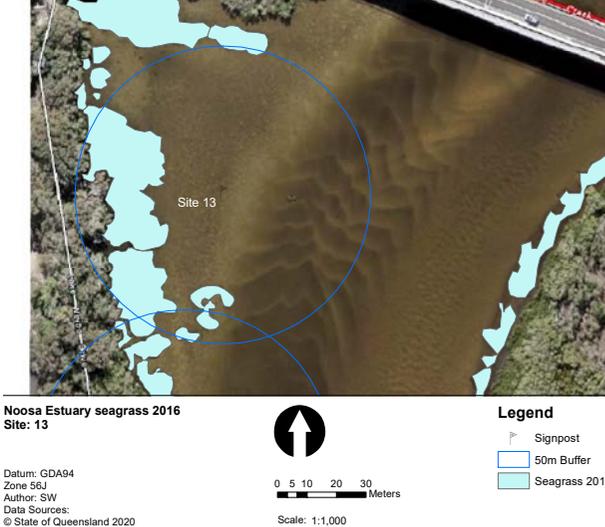
In May 2019, the pioneer seagrass species *Halophila ovalis* was observed growing within the RAA area at site 13 (Figure 20). Prior to reef deployment, this area was an unconsolidated mobile sand bank with no seagrass present. There was a reduction in the cover of the *Zostera* bed along the shoreline between July 2017 and May 2018, followed by a large increase, which has remained relatively stable between 2019 and 2020 (Figure 21; Table 3 & Table 4). The causal mechanism for this broader change is unclear; however, this area is adjacent to a stormwater outlet and the reduction in seagrass cover is likely due to external environmental factors, not the placement of restoration structures at site 13 or 14. We completed an additional historical assessment to examine the change in seagrass coverage within 50 metres of the restoration area using imagery sourced from Queensland Globe between 2015 and 2019, and found that the coverage of seagrass adjacent to Site 13 peaked in 2017, then declined by approximately half the area between 2017 and 2018 (Table 3). In 2019, the area covered was similar to that assessed in 2016 (Table 3). In contrast, at site 14 there has been an increase in coverage of seagrass (and seagrass wrack) adjacent to the restoration structures (Table 3 & Table 4).

Figure 21 Seagrass area in proximity to Site 13, pre- and post-deployment of oyster reefs

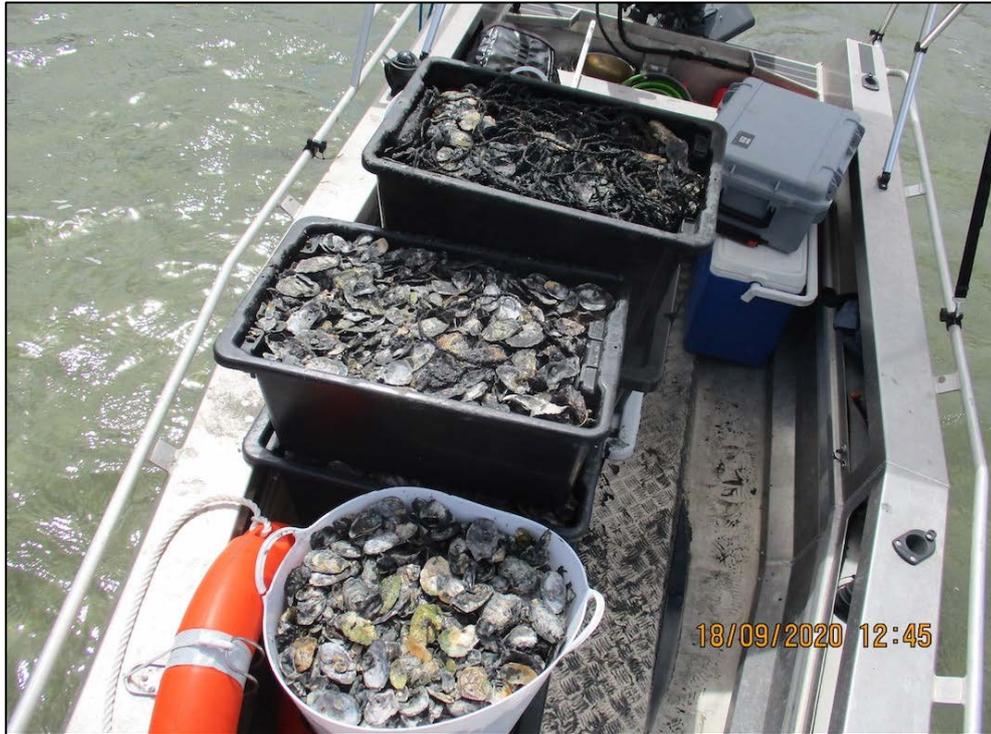
Figure 23 Oyster cultch removed and stored in tubs for disposal at the oyster shell recycling facility at Noosa Council Waste Depot

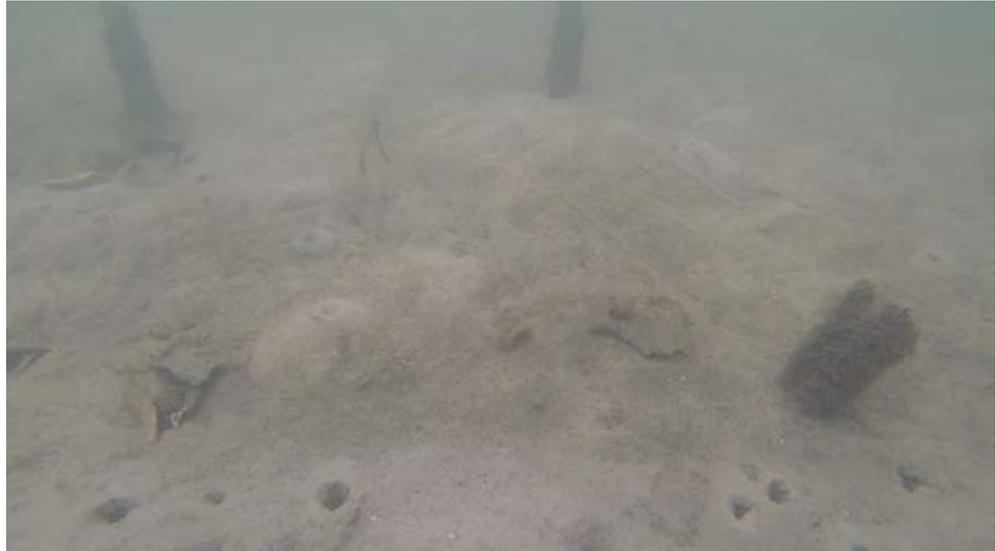
Site 12 –
Pre removal

September
2020

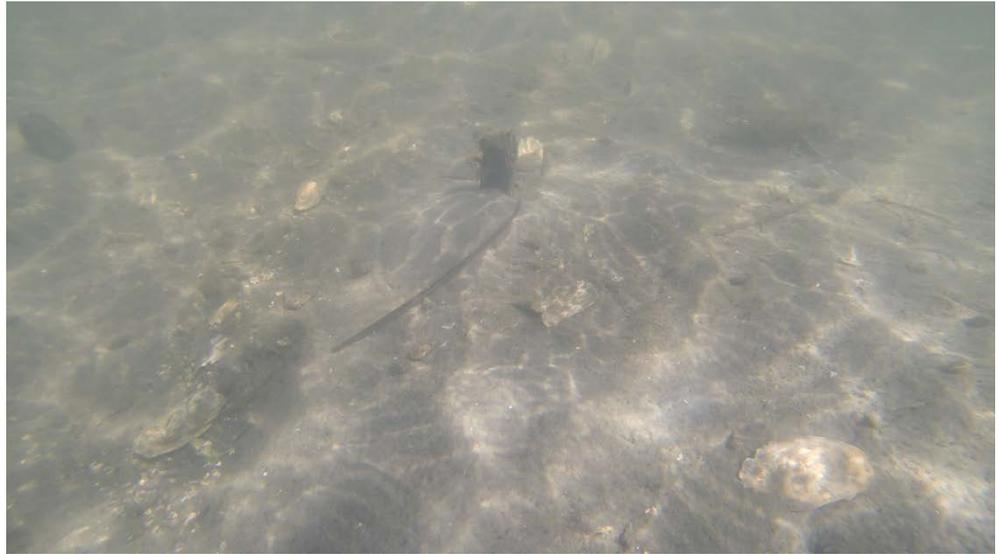
Site 13 –
Pre removal
September
2020

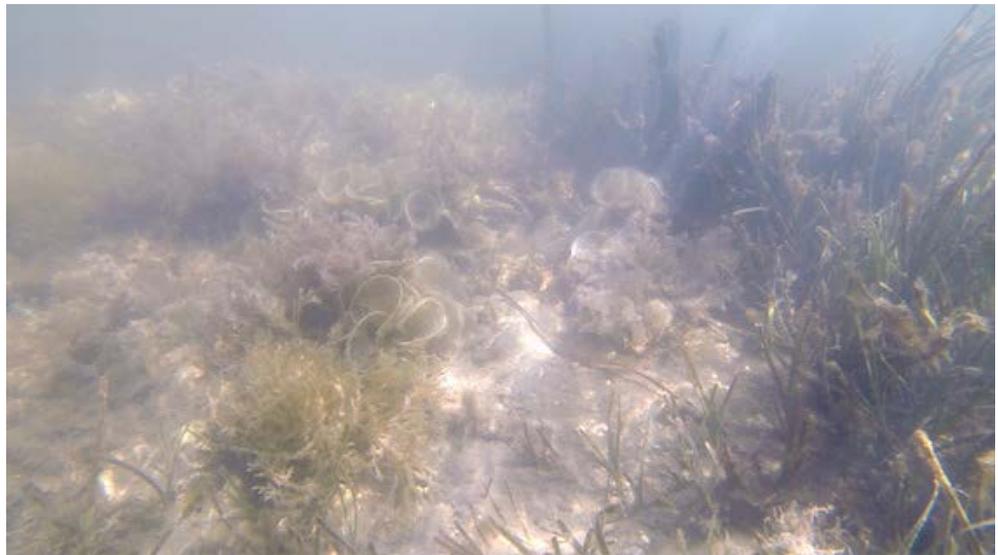
Site 14 –
September
2020

Site 14 – Reefs and signage has not been removed at this site
Post
removal

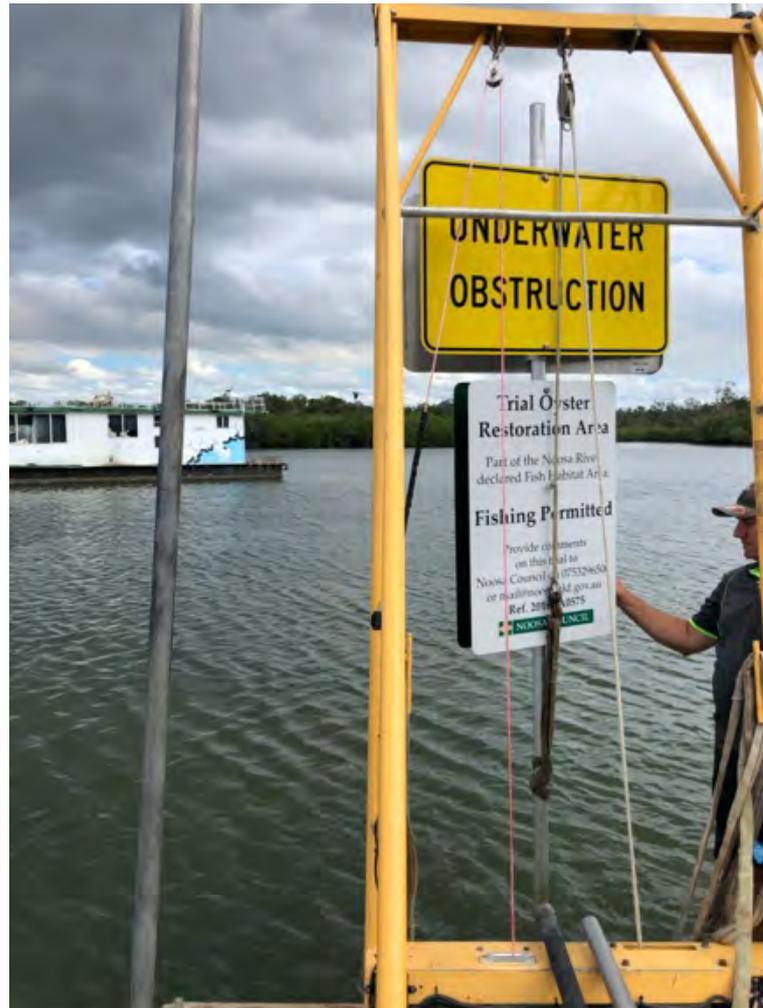
Figure 4 Manual winching signpost out at Site 6

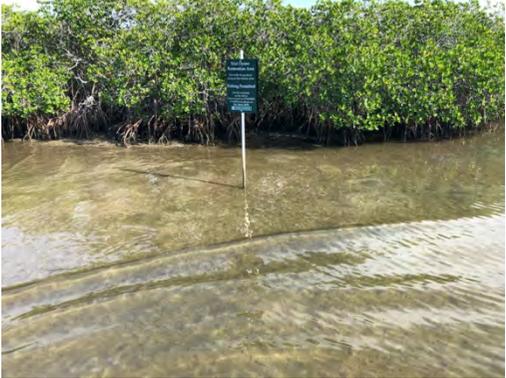
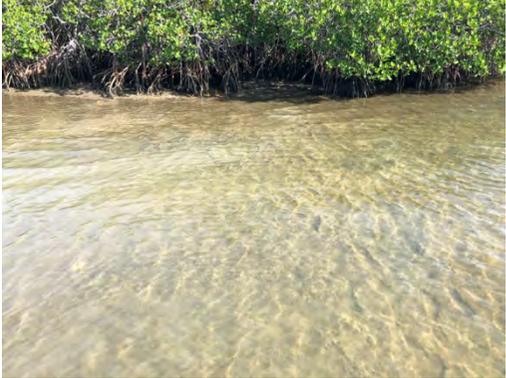
Site	Location (GDA94 Zone 56)		Before extraction	After Extraction	Extraction Method & Comments
	Easting	Northing			
Site 2	504561	7081869

Waterjet / Manual
Site 3	504300	7081484

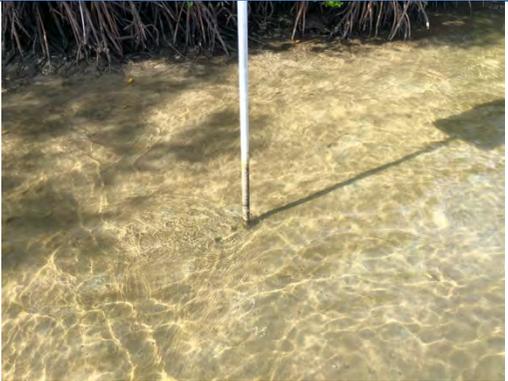
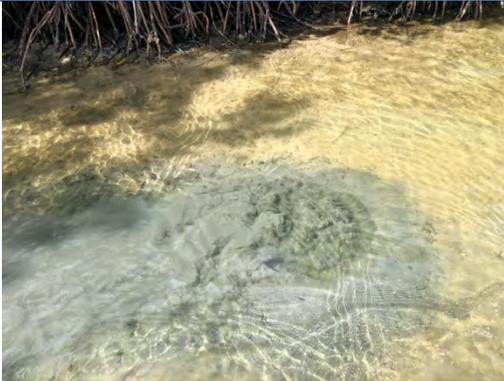
Site	Location (GDA94 Zone 56) Easting Northing	Before extraction	After Extraction	Extraction Method & Comments
Site 4	504451 7080720

Waterjet / Manual
Site 5	504980 7080597

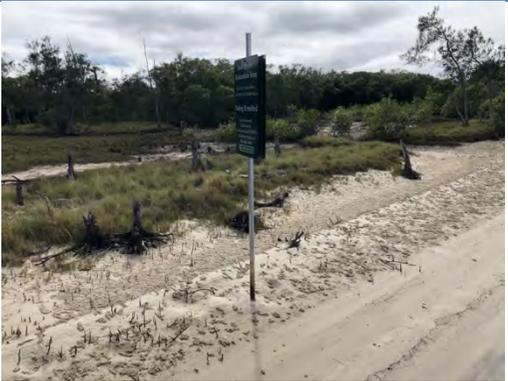
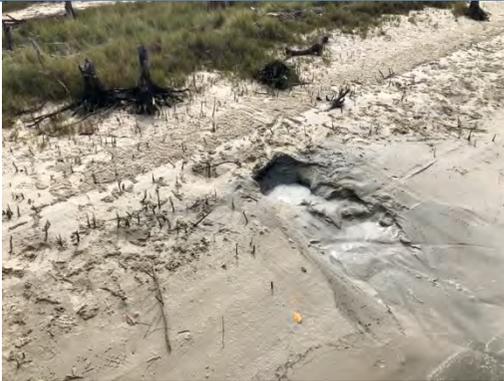
Waterjet / Manual

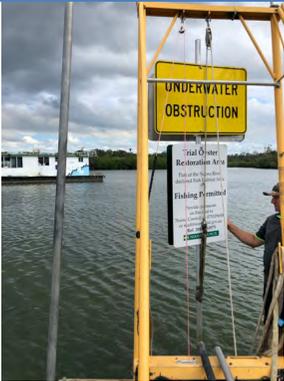
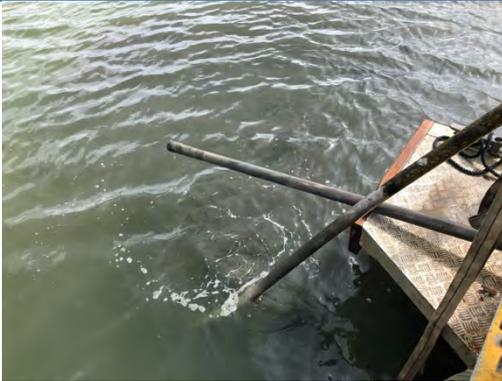
Site	Location (GDA94 Zone 56) Easting Northing	Before extraction	After Extraction	Extraction Method & Comments
Site 6	505144 7080846

Manual Winch
Site 7	505478 7080725

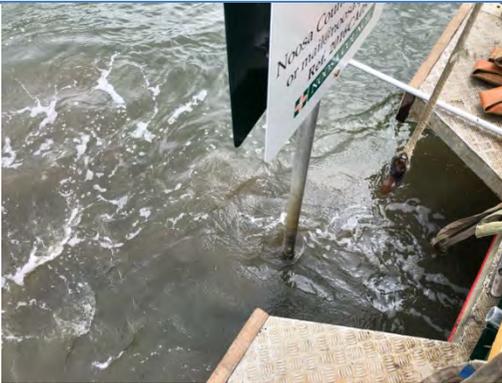
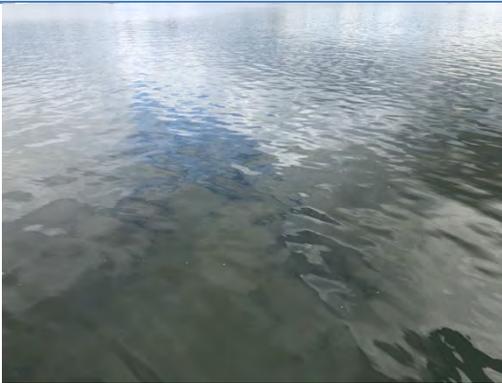
Manual Winch

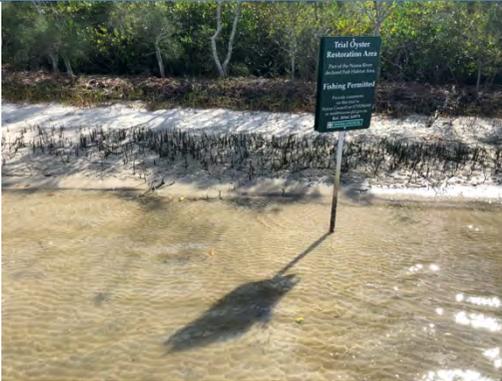
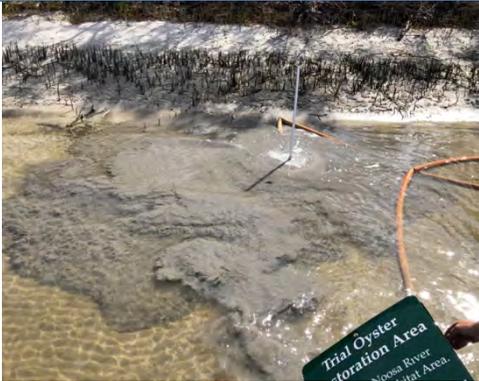
Site	Location (GDA94 Zone 56) Easting Northing	Before extraction		After Extraction	Extraction Method & Comments
Site 8	506152 7080581

Waterjet / Manual	
Site 9	507049 7081172

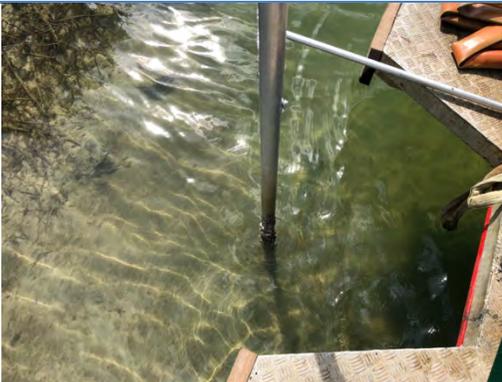
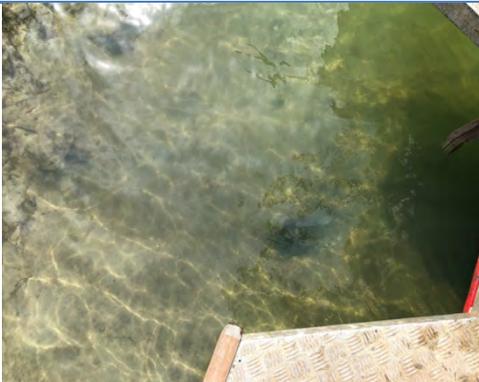
Manual

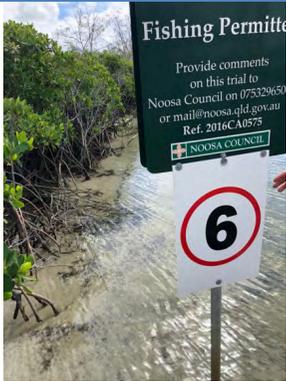
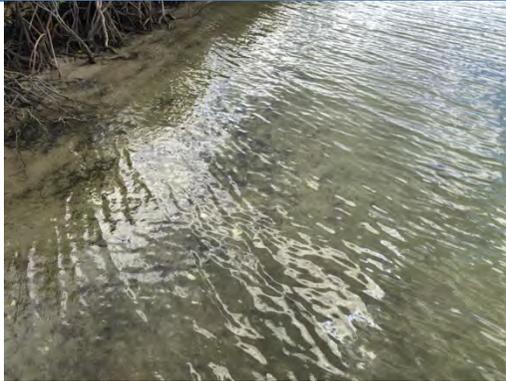
Site	Location (GDA94 Zone 56) Easting Northing	Before extraction		After Extraction	Extraction Method & Comments
Site 10	507135 7081730

Winch
Site 11	508038 7080214

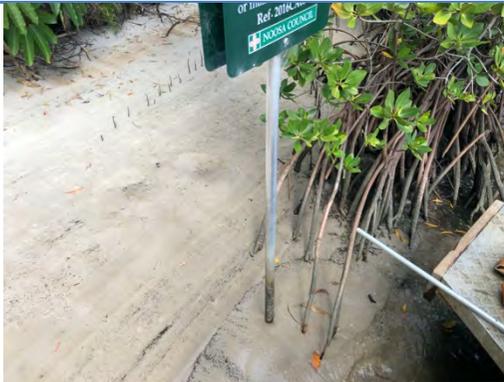
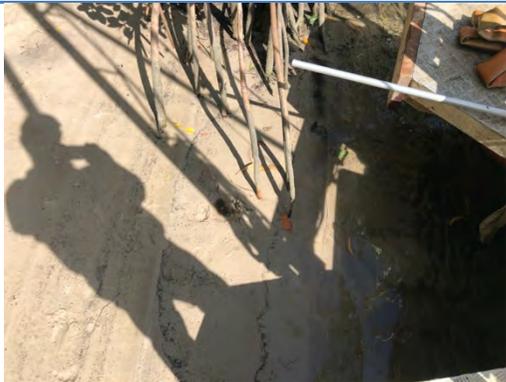
Manual / Winch
